THE ASSESSMENT OF THE CONCRETE STRUCTURE STADIUM "SJEVERNI LOGOR" IN MOSTAR

The paper presents the assessment of the stadium "Sjeverni logor" in Mostar, through the necessary steps in diagnosing the state of the existing structure: collection of existing documentation, inspection of the structure, testing and analysis, and assessment and decision on further action. Drawings of the stadium were made with defined damage and test points with non-destructive methods.

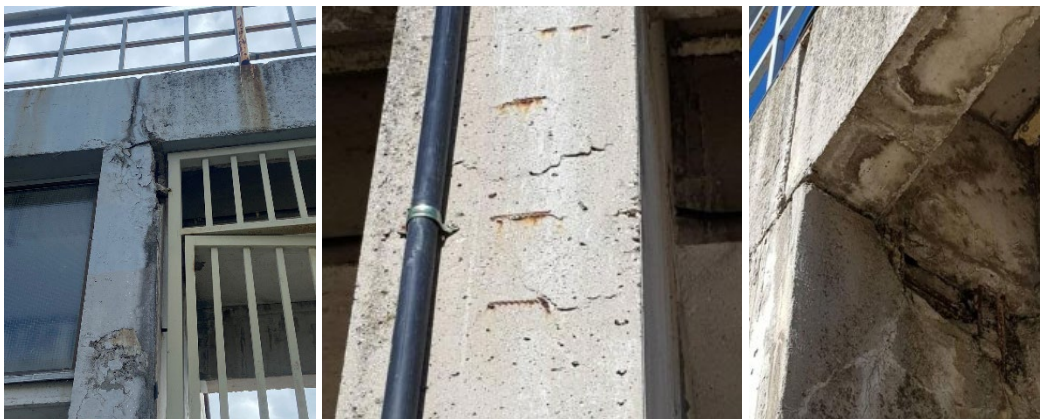
- Damage caused by moisture
- Degradation
- Segregation
- Appearance of vegetation
- Corrosion of reinforcement
- Cracks
- Deterioration

Figure 2. Examples of damages on construction (from left: cracks on column, corrosion, concrete separation)

In places where the column has cracked due to the horizontal movement of the beam, it is more economical to replace part of the structure. In such cases, it is necessary to ensure the adequate bearing capacity of the structure and the distribution of the load by means of appropriate systems for gluing or tying.

This method is mostly related to the corrosion of reinforcement. If the reinforcement is not sufficiently covered with concrete, adding cement mortar or concrete reduces the aggressive effect of chemicals.

This method is the traditional standard for repairing reinforced concrete. By removing the damaged concrete and re-covering the rebar, the steel is once again protected by an alkaline coating.

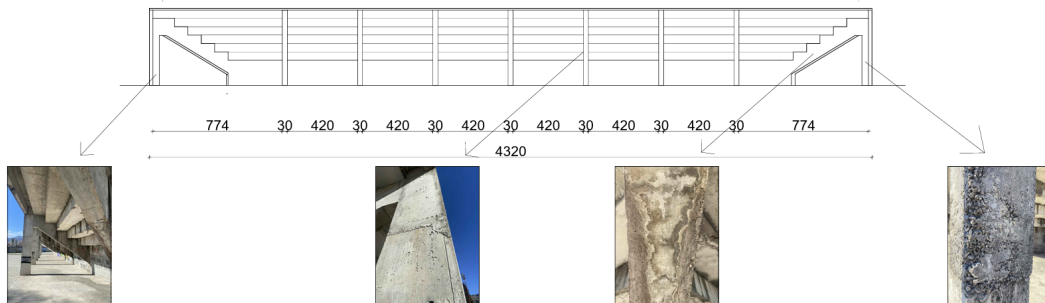
After the visual inspection, new blueprints of existing condition were created, due to lack of original blueprints. On these blueprints, all observed damages were defined (figure 3). Also, visual inspection provided data on damages on construction and points of in-situ tests.

Figure 3. Example of damages defined on blueprints

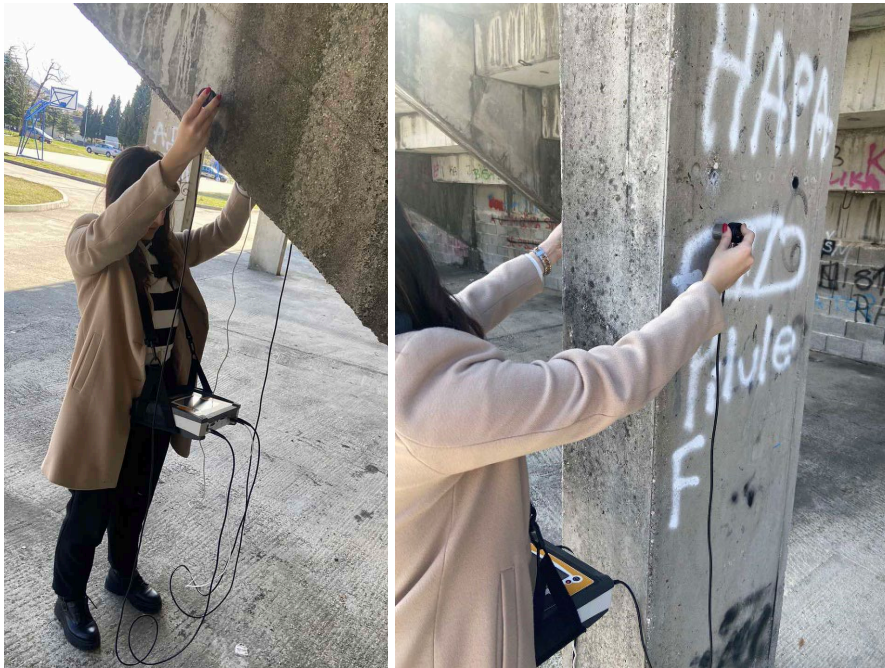
Based on the standard EN 12504-4, it is concluded that the concrete is mostly medium to good quality ($v=3,0 - 4,5$), due to average measuring values range about 4,00 km/s.

Figure 6. Ultrasonic pulse velocity test
