THE ASSESSMENT OF THE CONCRETE STRUCTURE STADIUM "SJEVERNI LOGOR" IN MOSTAR

The paper presents the assessment of the stadium "Sjeverni logor" in Mostar, through the necessary steps in diagnosing the state of the existing structure: collection of existing documentation, inspection of the structure, testing and analysis, and assessment and decision on further action. Drawings of the stadium were made with defined damage and test points with non-destructive methods.

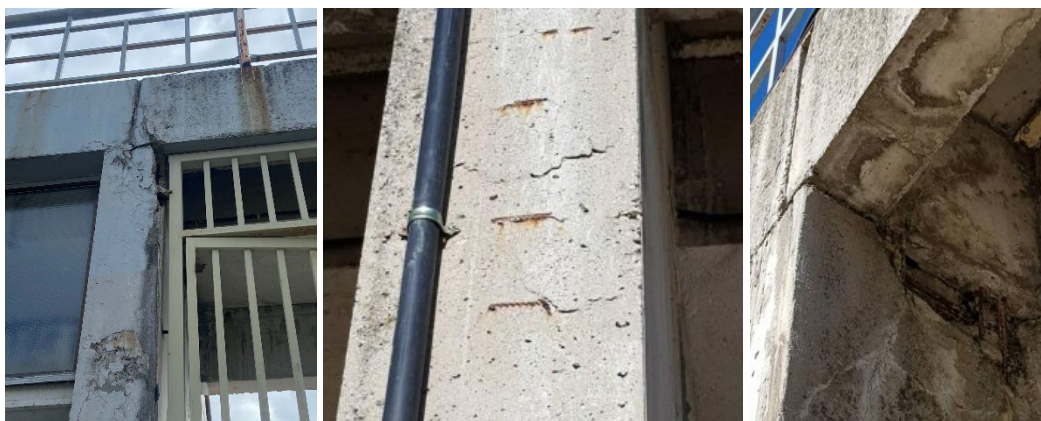
- Damage caused by moisture
- Degradation
- Segregation
- Appearance of vegetation
- Corrosion of reinforcement
- Cracks
- Deterioration

Figure 2. Examples of damages on construction (from left: cracks on column, corrosion, concrete separation)

It represents an established method of local repair of damage in concrete and is most often used for the repair of smaller areas. Mortars are specified in EN 1504-3. The goal of this method is to replace poor quality concrete with new mortar or concrete.

In places where the column has cracked due to the horizontal movement of the beam, it is more economical to replace part of the structure. In such cases, it is necessary to ensure the adequate bearing capacity of the structure and the distribution of the load by means of appropriate systems for gluing or tying.

It is done to prevent the penetration of aggressive substances into the concrete. This method is used for individual cracks or exceptional displacements of cracks that cannot be covered with coatings.

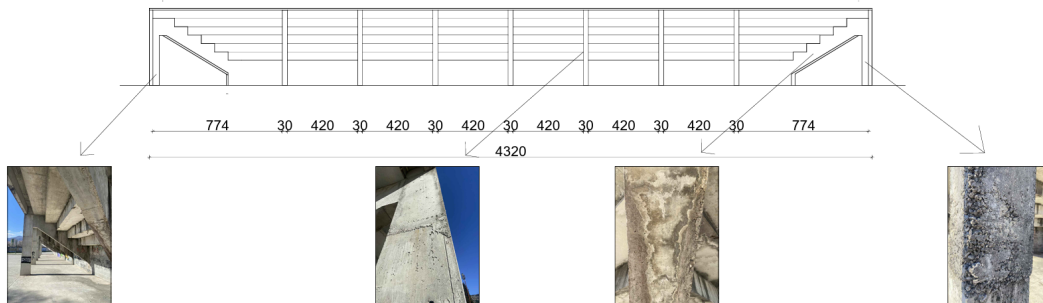
After the visual inspection, new blueprints of existing condition were created, due to lack of original blueprints. On these blueprints, all observed damages were defined (figure 3). Also, visual inspection provided data on damages on construction and points of in-situ tests.

Figure 3. Example of damages defined on blueprints

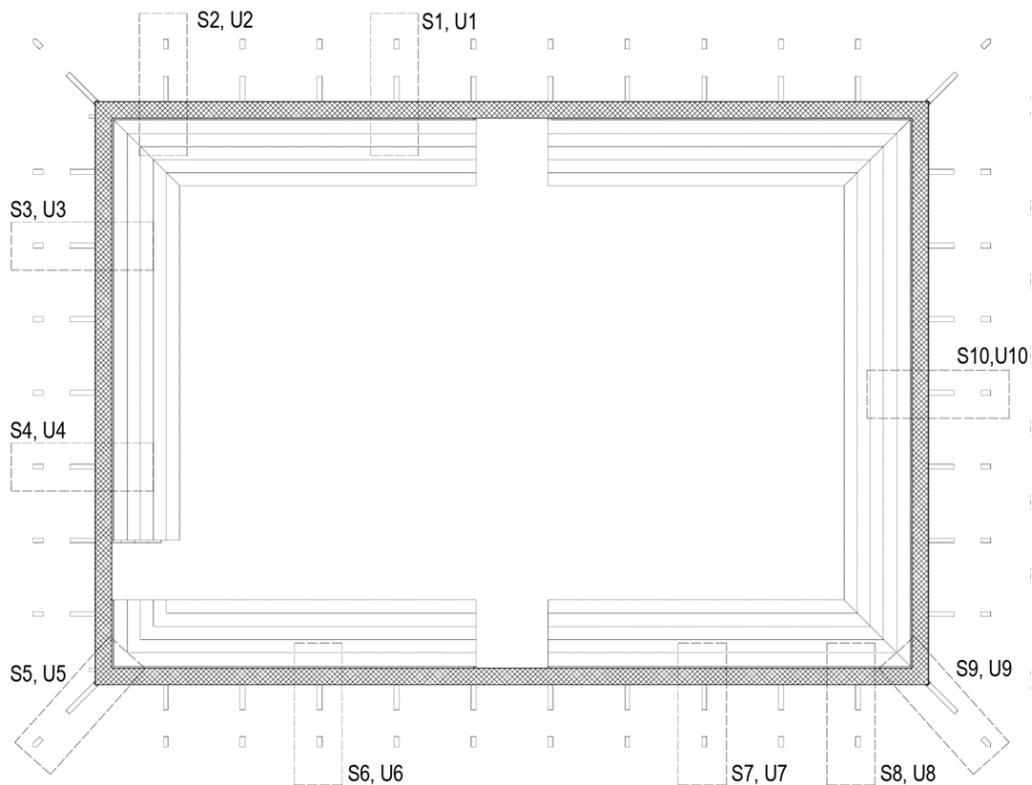
Tests were conducted on 10 columns and 10 beams. Of these, there are two pillars each in the western and northern tribunes and three pillars each in the southern and eastern tribunes. The points are given in figure 4.

Figure 4. Selected columns and beams for in-situ tests

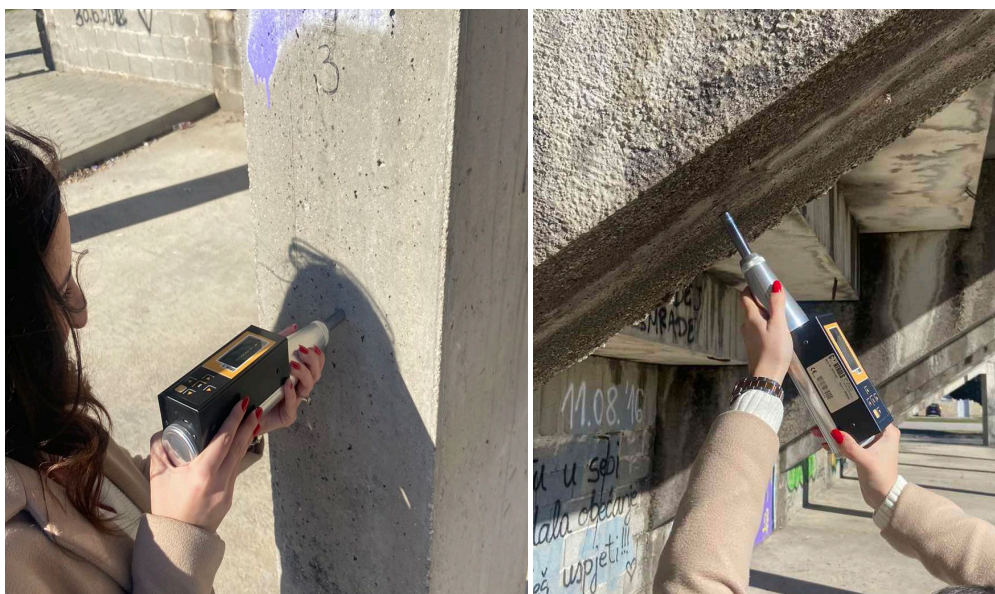
Location	Column	Beam
S1	40,36	62,76
S2	51,40	65,68
S3	56,50	54,84
S4	54,24	67,56
S5	65,05	61,08
S6	47,92	57,40
S7	56,98	52,10
S8	43,16	59,10
S9	73,60	48,71
S10	48,56	51,68
Average	53,78	58,09

Figure 5. Compressive strength tests

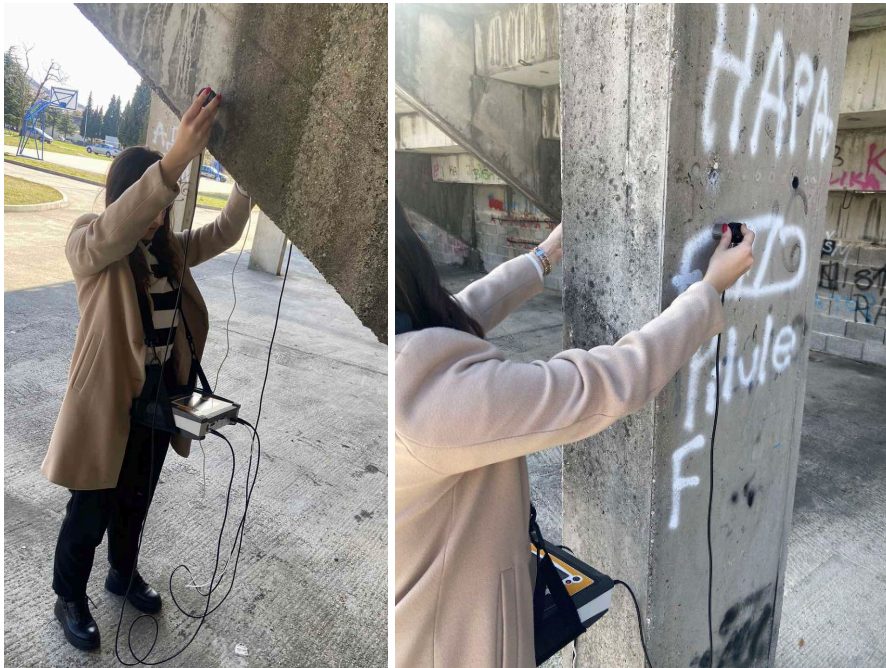
Location	Test	Column	Beam
S1	v (km/s)	4,20	3,41
	E_d (MPa)	38026,3	25103,3
S2	v (km/s)	4,48	2,65
	E_d (MPa)	43305,9	15170,6
S3	v (km/s)	3,68	3,89
	E_d (MPa)	29267,2	32703,0
S4	v (km/s)	4,07	2,38
	E_d (MPa)	35693,0	12225,5
S5	v (km/s)	4,20	3,41
	E_d (MPa)	38026,3	25046,3
S6	v (km/s)	4,28	4,40
	E_d (MPa)	39560,4	41795,3
S7	v (km/s)	4,32	3,55
	E_d (MPa)	40246,4	27290,5
S8	v (km/s)	4,35	4,26
	E_d (MPa)	40831,8	39112,7
S9	v (km/s)	4,38	3,55
	E_d (MPa)	41430,0	27290,5
S10	v (km/s)	4,17	4,48
	E_d (MPa)	37604,4	43435,4

Based on the standard EN 12504-4, it is concluded that the concrete is mostly medium to good quality ($v=3,0 - 4,5$), due to average measuring values range about 4,00 km/s.

Figure 6. Ultrasonic pulse velocity test
