ZOLLINGER LAMELLA VAULT OF EXISTING TIMBER HANGARS IN ŠIBENIK (CASE STUDY) – INITIAL CONDITION ASSESSMENT AND PRELIMINARY ANALYSIS OF GLOBAL STRUCTURAL FEATURES

A preliminary condition assessment using non-destructive testing methods for determining material quality, has been carried out on three adjacent wooden hangars near Šibenik with the aim of exploring the possibilities of their repurposing. Through visual inspection and detailed geometric measurements, it has been verified that their unique structure embodies the original Zollinger lamella vault system in which the joint typology is decisive for both, the overarching structural analysis and the execution of the structure. In this paper, the results of conducted investigation, including the developed detailed geometric model are presented, and guidelines for future comprehensive research focusing on the influence of joint stiffness on global structural features are discussed, as well.

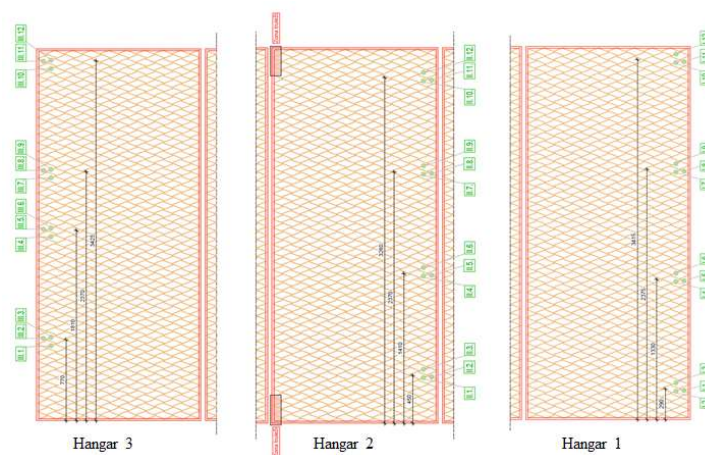
without doors for years). Along the gables on the south-west side of Hangar 2 (the area at the base of the vault, along the gutter towards Hangar 3), the covering panels were completely destroyed, and the inevitable rotting zones of the timber structure were also detected there (lamellae, edge beams and arches). No significant mechanically induced damage to the lamellae were observed, although it does occur occasionally, albeit in negligible numbers. It can also be seen that some (e.g. along the entire length of one side of Hangar 3, the lower part of the vault) were caused by the removal (probably by pulling) of something when leaving the hangar. The consequences of the "work" of the connections are also visible in some areas – although the ends of the holes in the lamellae are rounded, damage around the holes was observed on a smaller number of lamellae in the lower sections of the vaults, regularly combined with degradation of the material due to wetting (areas with gaps between the covering boards). Longitudinal cracks on the connected lamellae (extending from the joint) are also observed. The lamellae are made of larch wood and are generally in good condition despite visible signs of ageing (the timber has hardened and undergone all rheological changes without significant dimensional changes) and aesthetic damage (discoloration). All anchors, bolts and washers have completely corroded. Results of the survey are shown on Figures 7, 8 and 9.

Figure 7. Probe positions and location of detected decay (dry rot) in Hangar 2 [2]

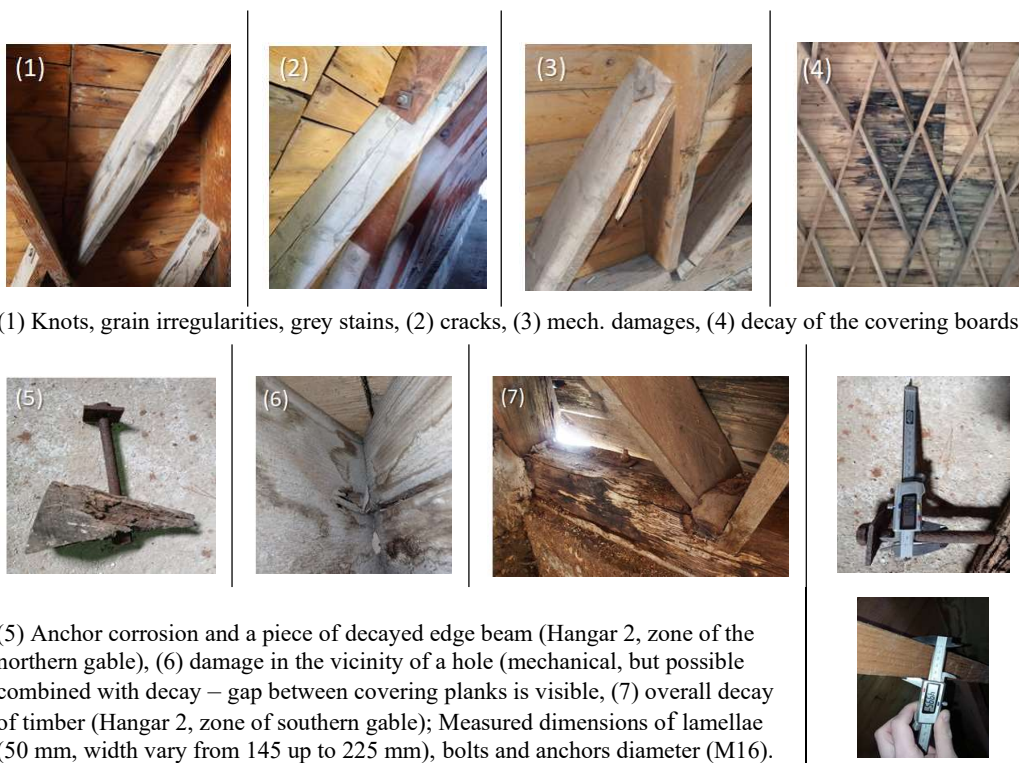
A visual inspection confirmed the obvious consequences of years of neglect of the hangar. Apart from the fact that the covering made of curved asbestos-cement panels is not acceptable for any current use, localised damage to the covering (gaps in the areas of the panel joints) and the bitumen pasteboard has led to deterioration of the timber formwork and the visible consequences of its long-term wetting on significant areas of the vaults. Localised structural degradation of the edge base beams, which are anchored in low concrete walls, is also evident, particularly at the gables where the ends of the beams are protruding. Structural damage is also visible at the rarely accessible parts of the edge arches (they are two-part, bolted together from the lamellae and hidden by gable walls made of masonry blocks). The consequences of exposure to moisture are also visible on the timber lamellae of the vaults, with the discoloration (greying due to surface erosion) being more pronounced in the zones where they have also been exposed to the sun (the hangars have been

Figure 8. Observed damage types (brief overview) and measured dimensions [2]

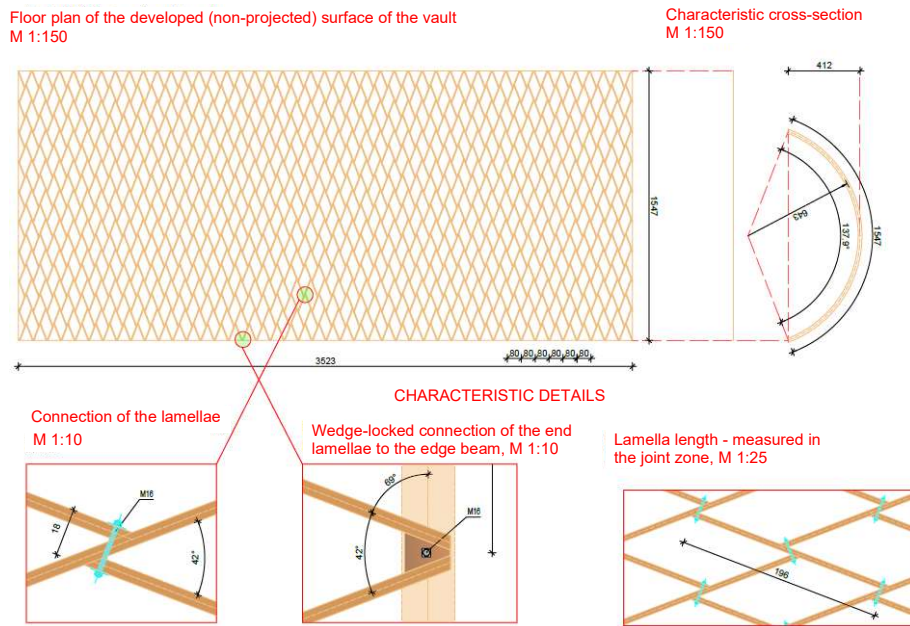
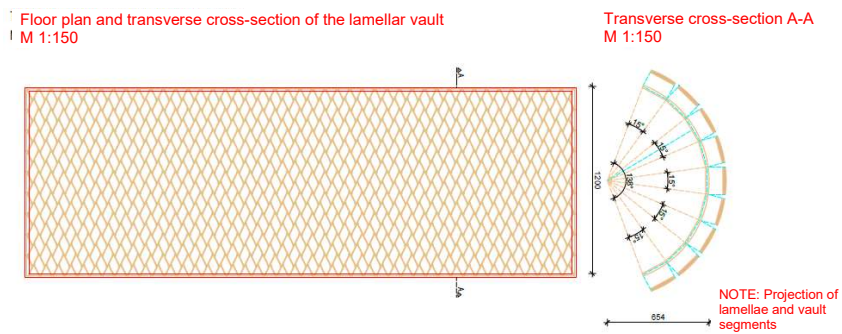
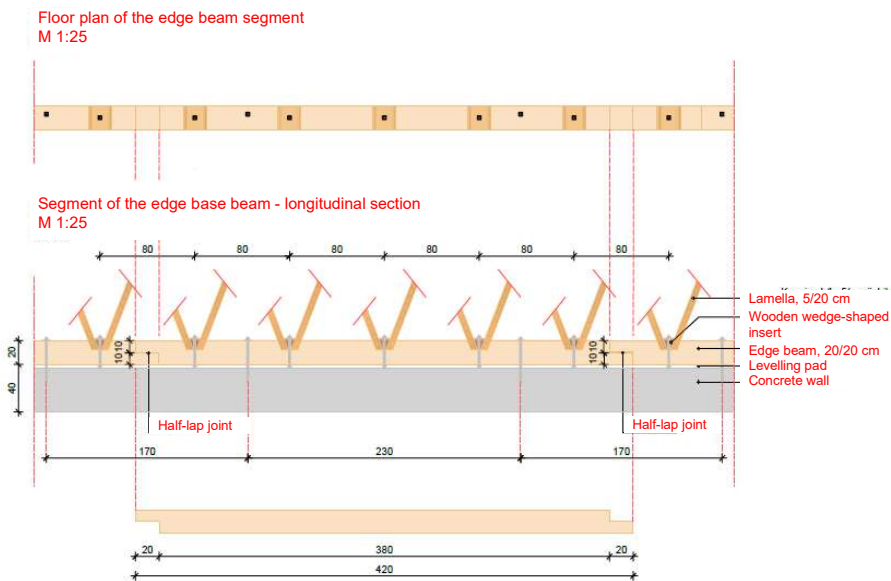
Figure 9. Drawings resulted from measured survey [2]

Floor plan dimensions (diamond grid), height of the structure and essential geometric measured parameters

Projections: floor plan (grid: 44 x 0,8 m) and cross-section of the vault (division into 9 segments)

Edge beams – joining of adjacent segments in the queue and arrangement of anchoring in concrete wall

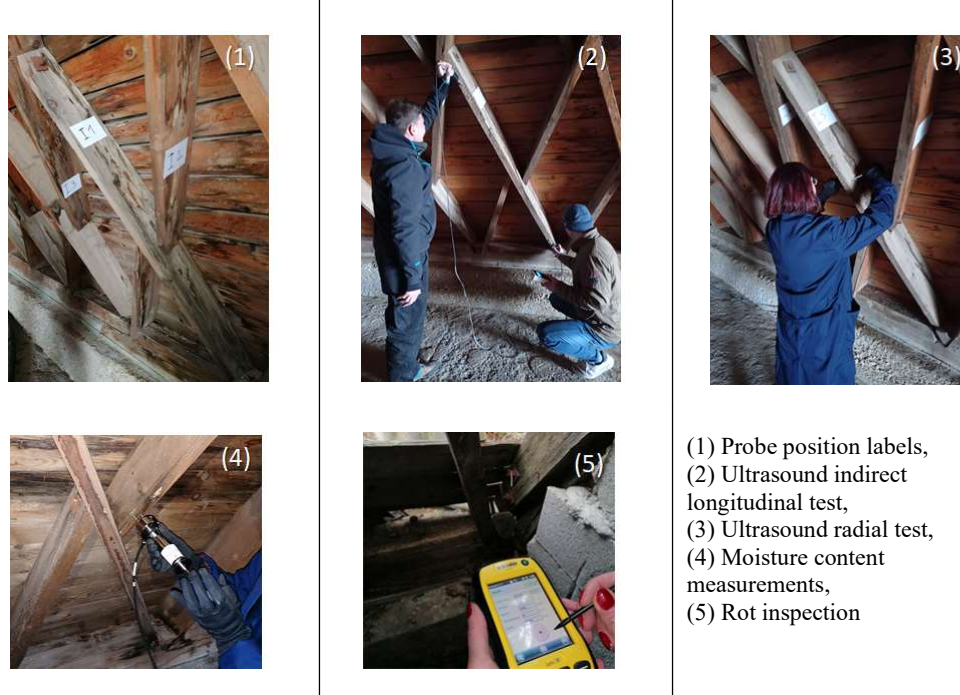
(1) Probe position labels,
(2) Ultrasound indirect longitudinal test,
(3) Ultrasound radial test,
(4) Moisture content measurements,
(5) Rot inspection

Figure 10. Material properties determination – ND tests and used devices [1, 2]

Based on the conducted hygrometric tests on the equilibrium moisture content of wood, which varies between 12.4% and 13.8% for Hangar 1, between 12.0% and 14.8% for Hangar 2, and between 12.4% to 13.4 % for Hangar 3 (depending on the probe position, where three measurement were made for each probe) it can be concluded that the average measured values are 13.2% for Hangar 1 and Hangar 3, and 12.9% for Hangar 2. As the equilibrium moisture content in the wood does not exceed 20%, it may be considered that the existing structure meets the requirements for service class

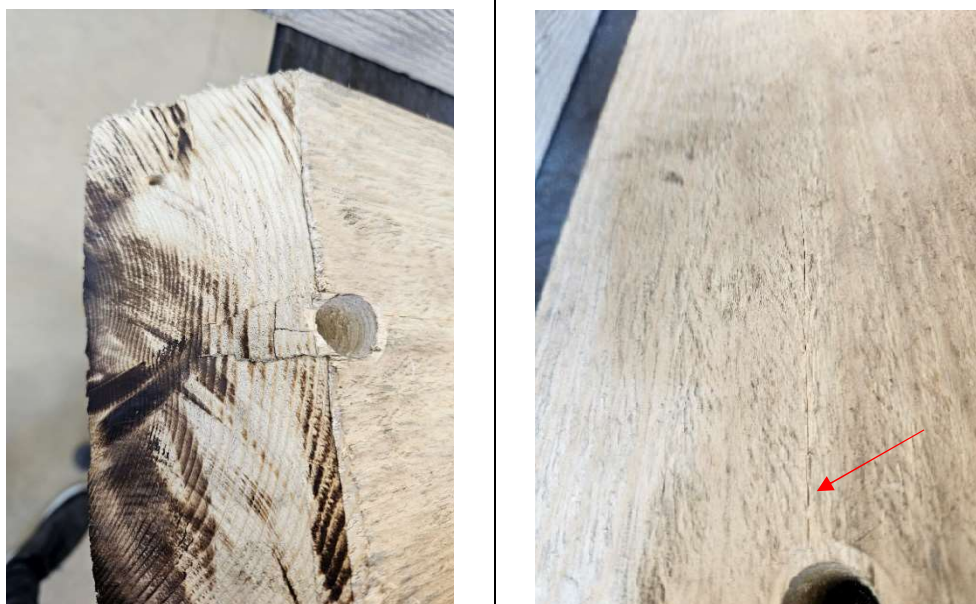
The failure force was assumed based on an experiment available in the literature, where the samples were scaled (1:2) [18]. The underestimated capacity suggests nonlinear and complex relationships between the dimensions of the components in the connection and the failure force. The connection failure occurred during a repeated attempt, and the failure pattern resembles the damage observed in the structure (Figure 8) – crushing around the hole combined with shear failure and a longitudinal cracking extending from the hole (Figure 14).

Figure 14. Observed types of failures
