## STRUCTURAL VULNERABILITY ASSESSMENT OF AN HISTORICAL MASONRY BUILDING – CASE STUDY

This paper presents a vulnerability assessment of an historical masonry building representative of early 20th-century construction. The structure consists of load-bearing masonry walls with timber floors and lacks seismic detailing. The methodology included visual inspection, typological classification and simplified control analysis. Observed damage includes masonry cracking, mortar degradation, timber floor deflections and local foundation settlements. The assessment indicates insufficient global structural integrity and pronounced vulnerability typical of historical unreinforced masonry buildings. The results support decision-making regarding strengthening or demolition of severely degraded masonry structures.

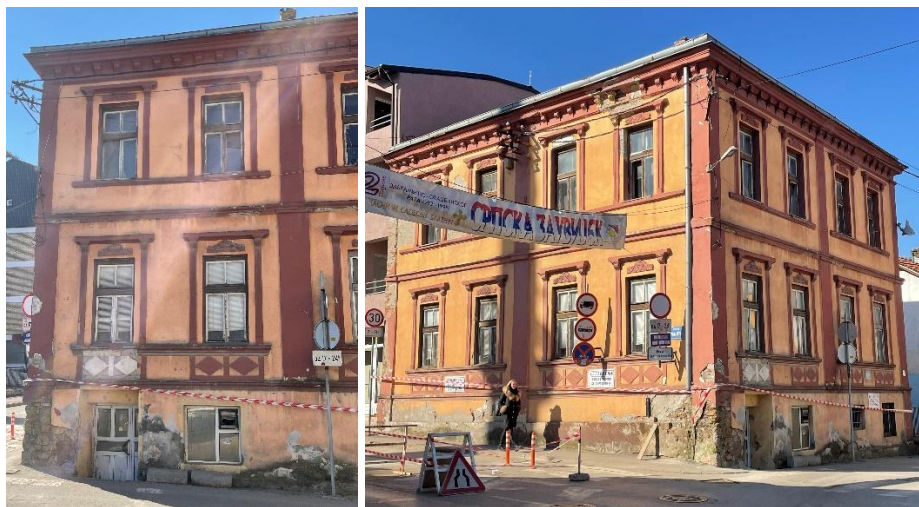
It was used for mixed residential and commercial purposes as shown on Fig. 1.

The building is currently not in use, as certain zones are in an advanced stage of degradation and collapse.

Figure 1. Current state of the object – façade (photography by author)

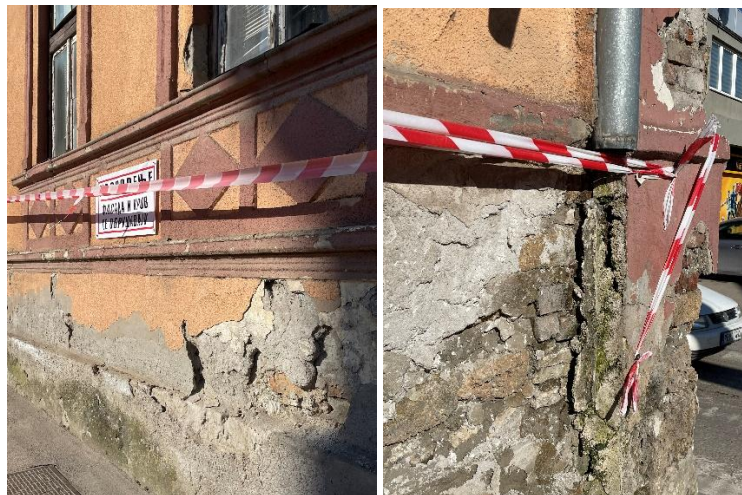
- Cracks were observed in the massive plinths due to their brittleness and degradation of the mortar in the joints and on the external surfaces,
- In some areas, the soil and foundation gave way, i.e., there was local uneven subsidence of the building.

- The foundation and plinth masonry was made of semi-finished stone in poor quality lime mortar;
- The foundation and plinth walls do not have elements for adequate weighting and preservation of the necessary connection and integration of the soil-structures.

Figure 2. Current state of foundations (photography by author)

The foundation structure consists of strips of stone in low-quality lime mortar. The lack of ductile elements (reinforcement) is an important factor that can jeopardize the safety of the foundation and the building as a whole, in asynchronous conditions of soil oscillation.

Masonry foundation strips, as a rule, require reinforcement in order to form a well-connected system. In the case at hand, it would be most appropriate to envisage the construction of a reinforced concrete ring around the building, with adequate anchoring to the existing foundations, with additional pouring of concrete and the formation of plugs.

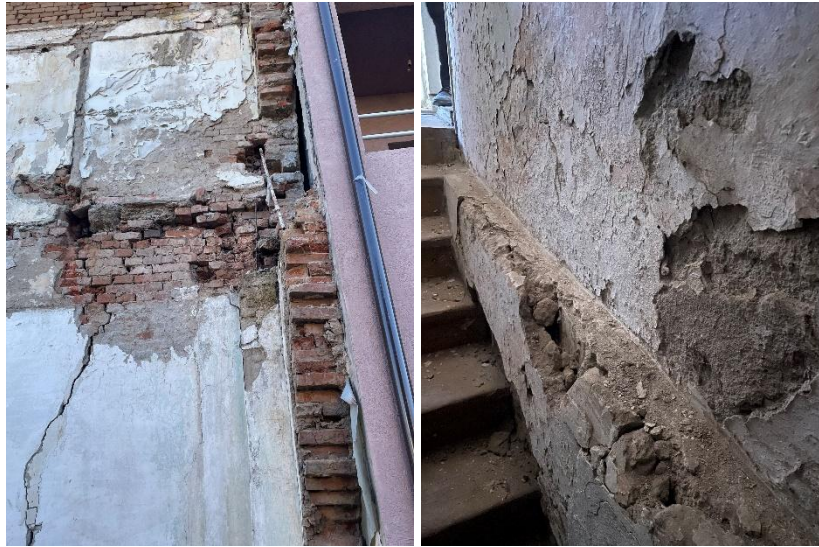
- Vertical and diagonal cracks in walls and parapets, especially at wall intersections and around openings;
- Spalling and detachment of bricks in walls;
- Detachment and falling off of mortar from wall surfaces.

- Lack of vertical and horizontal reinforced concrete tie-columns/ring beams to provide confinement and preserve the integrity of massive brittle masonry walls;
- Lack of reinforced concrete lintels and tie beams above openings to ensure continuity of masonry around openings;
- Low shear resistance of masonry piers between openings;
- Poor quality of lime mortar in joints (the mortar crumbles easily when pressed with fingers), resulting in low shear resistance of masonry walls.

Figure 3. Current state of walls (photography by author)

For modern conditions, the quality of existing masonry walls is below the limit of acceptability, primarily due to the use of a weak binding agent - lime mortar, and its aging and degradation over time [8]. Such mortar was used (without the addition of cement) which is considered to have a weak resistance to shear forces, and its use is prohibited by modern aseismic regulations [4], [8].

The inter-window columns are not framed with reinforced concrete, which is why they represent the most critical zones that can be significantly damaged or collapse under the action of seismic forces. The above-mentioned defects, in superposition with the degradation of the material, when it comes to the applicable regulations, sufficiently indicate the degree of aseismic irregularity of the masonry building in question.

Interventions aimed at reducing the existing mass of the object, centering the stiffness and masses and constructing new walls are, realistically speaking, not possible. Hence, a solution is imposed in interventions on load-bearing walls, e.g. by introducing RC ties and/or reinforced parts in the form of wall cladding with shotcrete concrete. In doing so, it is very important to ensure a good connection of the newly added elements/cladding with the existing walls and foundations. It is best to cover the walls with reinforced concrete on both sides, with anchor connections of these coverings through the wall. If it is a case of covering on only one side, then, in order to form a better bond of the wall panel, in addition to the usual use of anchors, it is necessary to use concrete plugs. Prestressing the walls provides certain advantages, because it does not change the appearance of the walls/building, which is important for protected objects. However, this is a specific procedure that requires special equipment and experience, and such interventions have not been carried out in our area so far. Something similar can be said about the use of carbon strips and canvas, although this method of reinforcement could be considered with proper installation and protection.

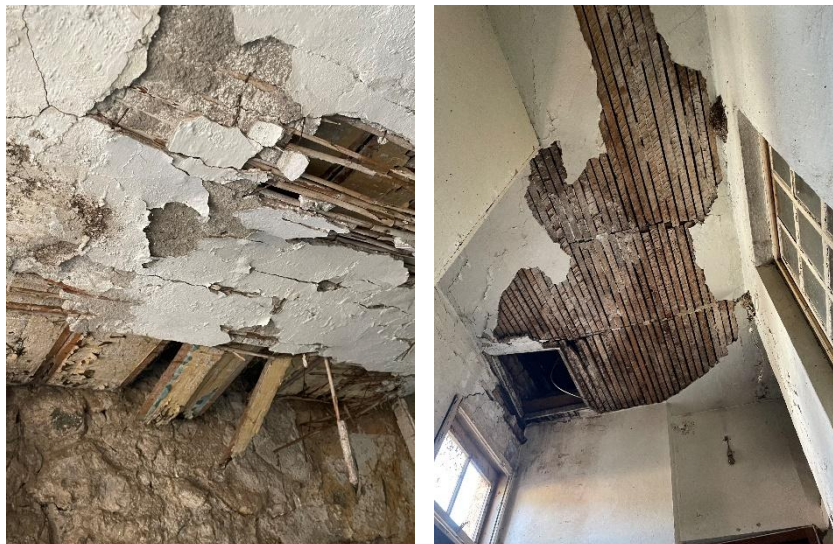
- Permanent sagging of ceilings;
- Damaged and broken wooden beams;
- Cracks and fissures in ceilings;
- Peeling of ceiling plaster and filling;
- Damaged wooden floors.

- Wooden ceilings were constructed without special elements for their high-quality weighting and connection to the walls, i.e. without a rigid (e.g. reinforced concrete) layer. Such ceilings cannot be treated as rigid horizontal slabs, because they are not able to safely accept and distribute horizontal (seismic) forces to the load-bearing walls. In other words, wooden ceilings cannot play the role of floor “RC ties” that would significantly improve the stability of the walls and the building as a whole.

Figure 4. Current state of mezzanine construction (photography by author)

Wooden inter-floor structures, which transfer the load in one direction, and which do not have stiffening elements, do not meet the basic requirements for seismically regular ceilings [1], [6]. The distribution of horizontal floor forces on the load-bearing walls is problematic due to the insufficient rigidity of such ceilings and their weak connection to the walls. It is well known that reinforced concrete slabs meet these conditions and ensure the aseismic regularity of buildings, while wooden ceilings are most often unable to provide this. In the case of the building in question, wooden ceilings are not able to connect the walls as required by modern principles of aseismic construction. This condition promotes progressive cracking and separation of masonry wall panels under horizontal loading, especially in the absence of strong connections from the other direction, i.e. in the absence of horizontal RC ties.

Wooden ceilings are a particular problem for several reasons that have been previously stated. That is, it is necessary to ensure that the ceilings have sufficient load-bearing capacity and stiffness to reliably accept all the anticipated impacts. It should be borne in mind that the existing wooden ceilings do not meet the above conditions and are significantly degraded. Partial or complete construction of new wooden ceilings requires a series of additional operations in the form of their weighting and connection to the walls, which is not an easy task. However, this can be achieved by connecting wooden beams with a reinforced concrete slab and adequately connecting them as a whole to the load-bearing walls (e.g. horizontal braces). Another option would be to completely remove the existing wooden ceilings and construct new reinforced concrete slabs. Wooden stairs also require similar work, but it is best to replace them with reinforced concrete or steel ones, considering that this is a building for collective housing.

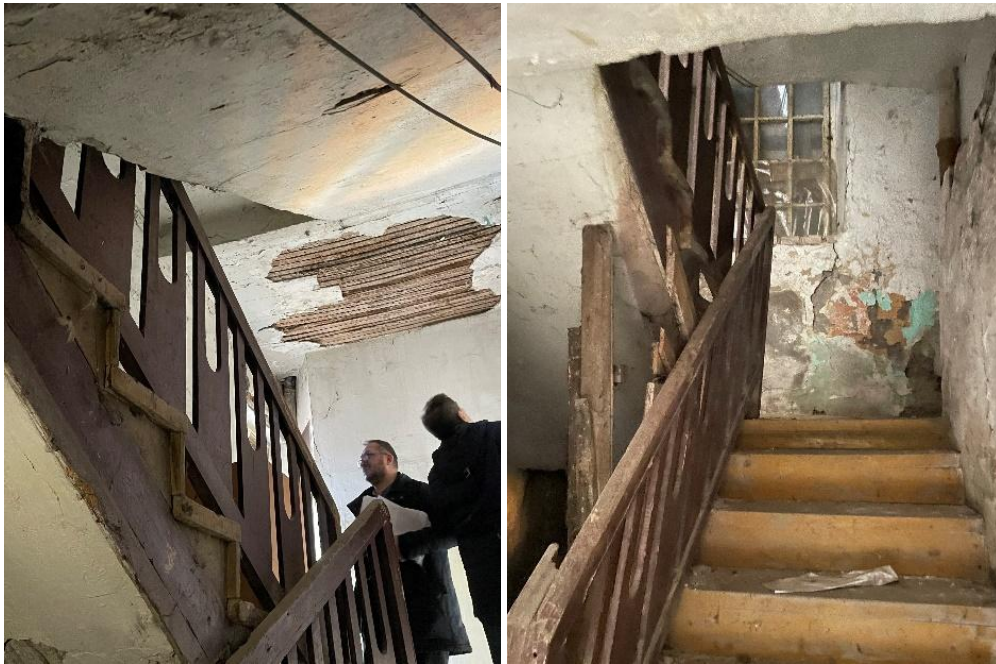
- Permanent sagging of stair treads;
- Damaged and broken wooden beams;

- Wooden staircases are not recommended for residential buildings for several reasons.

Figure 5. Current state of staircase (photography by author)

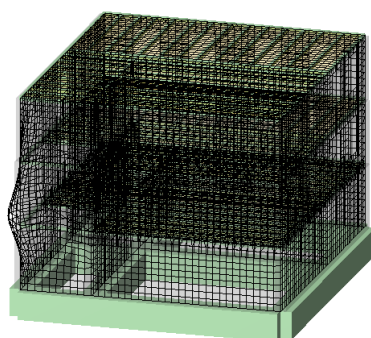
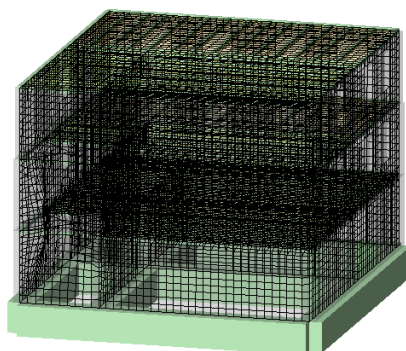
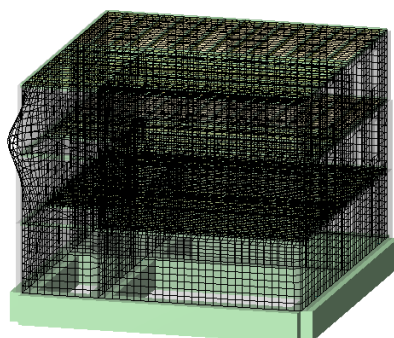
Figure 7. Static calculation - modal tone 1/20 (drawing by author).

Figure 8. Static calculation - modal tone 2/20 (drawing by author).

Figure 9. Static calculation - modal tone 3/20 (drawing by author).

The simplified control structural analysis, including modal evaluation, revealed dominant local vibration modes of masonry wall panels, while global structural response occurred only at higher modes. Such dynamic behavior indicates insufficient global structural integrity and an increased likelihood of local wall instability under seismic excitation.
