## METHODS FOR STRUCTURAL CONDITION ASSESSMENT AND PROOF LOAD TESTING: A CASE STUDY OF THE CAMPUS GARAGE AT THE UNIVERSITY OF BANJA LUKA

This paper presents a comprehensive condition assessment of the campus garage at the University of Banja Luka. The assessment methodology included visual inspections, non-destructive testing (NDT) of concrete using rebound hammer and ultrasonic pulse velocity methods, and proof load testing of the primary roof truss. Deformations were monitored using dial gauges, deformeters, and geodetic instruments, specifically laser scanning and digital levels. Numerical modeling was conducted to determine the theoretical deflections of the roof truss, with particular emphasis on the specific characteristics of the bottom chord. The key contribution of this work lies in the comparative analysis of results obtained through different methods and measuring devices. This study aims to enhance the condition assessment of similar structures and provide a framework for the future Code of Practice for Structural Assessment in the Republic of Srpska.

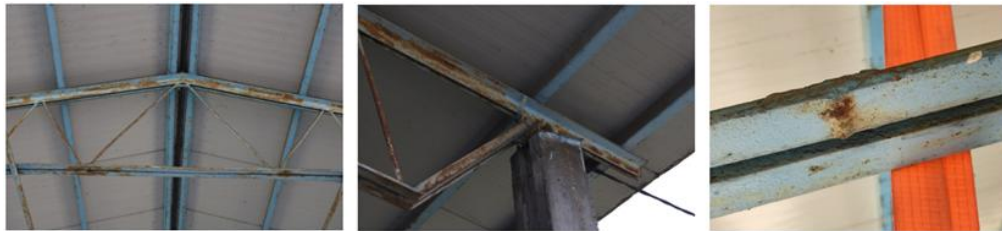
Corrosion observed on the steel members and welded joints, as shown in Figure 2, indicates long-term exposure of the structure to adverse environmental actions and insufficient corrosion protection.

Figure 2. Typical examples of corrosion on steel members and welded joints (photography by author).

A correct and accurate assessment of the condition of a structure subjected to degradation processes represents the foundation of any successful rehabilitation strategy. Based on the identified damage and defects, appropriate rehabilitation measures should be defined for the structure under consideration. These measures may include removal of the damaged concrete cover and its replacement with new material, such as new concrete, repair mortar, or another appropriate repair material. Prior to this, thorough cleaning of corroded reinforcement bars is required, followed by the application of protective treatments to prevent further corrosion development. Similarly, corrosion of steel girders may be removed mechanically or by sandblasting, followed by the application of appropriate corrosion protection systems.

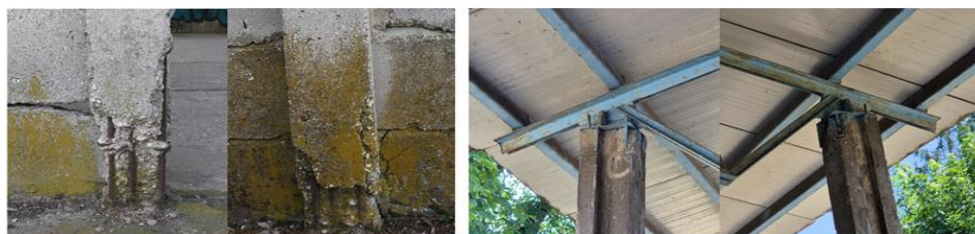
Spalling of the concrete cover was observed on most columns, primarily localized in the lower region of the column and in the upper region near the anchor plate. Inspection revealed that the concrete contained river aggregate with a nominal maximum size of 32 mm. In many locations, insufficient compaction of the concrete is evident, which, after decades of service, has contributed to the observed level of deterioration. The damage in the lower regions of the columns, shown in Figure 3 (left) from the base up to a height of 1.70 m, is additionally attributed to the combined action of frost and de-icing salts, with the latter being introduced via vehicle tires. The deterioration observed in the upper regions of the columns (Figure 3, right) results from the synergistic effects of inadequate concrete compaction and mechanical actions induced by the operation of the anchors under various service conditions. Localized concrete detachment was typically observed around one to two anchors.

Figure 3. Spalling of concrete cover in column lower zones (left) and upper zones near the anchor plate (right) (photography by author).

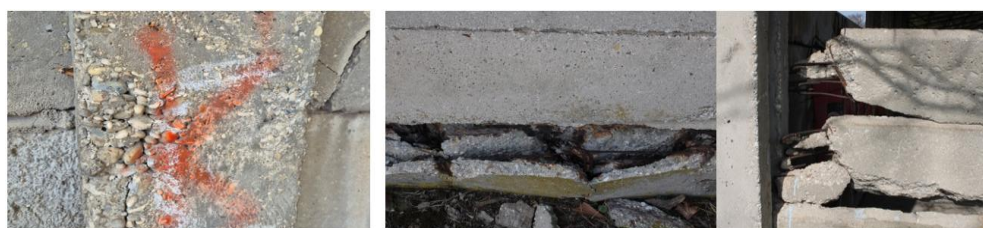
Significant concrete segregation was observed in several locations (Figure 4, left), with a complete absence of cement paste in zones extending up to half of the column width. At these locations, a local reduction in concrete strength of over 40% is estimated [2].

Non-structural parts of the structure – the parapet walls were severely damaged at numerous locations. Characteristic examples are shown in Figure 4 (right). Large portions of concrete were detached, the reinforcing steel was exposed and corroded, and vegetation growth was observed on the exterior surfaces of the walls.

Figure 4. Segregation of concrete in the columns (left) and deterioration of non-structural elements (parapet walls) (right) (photography by author).

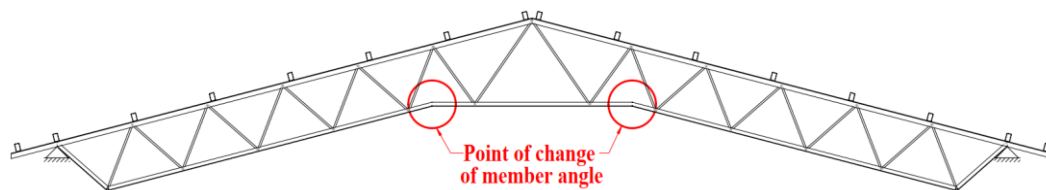
At the time when the project was executed, the design calculations of structural elements were carried out using simplified procedures (without the application of advanced software tools that are commonly used in current engineering practice). This indicates that the analysis of the truss girders was performed using a model composed of straight bar elements with concentrated loads applied at the joints. However, during the construction phase, deviations from the design model occurred, and the girders were executed with a different geometry, as shown in Figure 5.

Figure 5. Polygonal configuration of the lower chord of the main truss girder (drawing by author).

In the continuation of the study, the actual (polygonal) structural model is analyzed, which was found not to satisfy the load-bearing capacity criteria for the design loads according to the JUS regulations. This result indicates the need for a more detailed analysis in order to explain how the structure has successfully withstood significant loads during service, particularly snow loads, which on several occasions exceeded the design values (a characteristic example being the snow load recorded in December 2024).

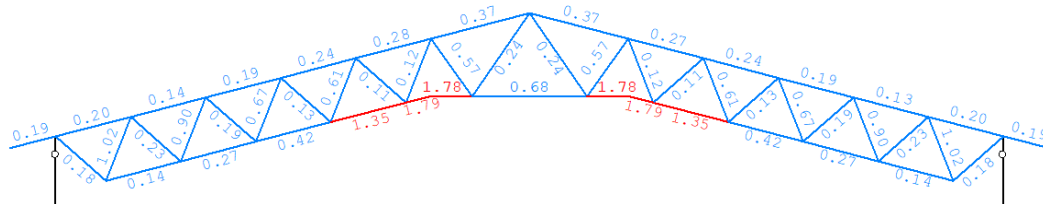
Figures 9 and 10 present the results of the stability check (without reduction of the allowable stress) for the polygonal and idealized models, respectively. Members of the lower chord of the polygonal model whose bending moments induced significant stresses exceeding the allowable values are marked in red. It was established that these members satisfy the stability criteria for the combination of permanent load plus 44% of the snow load.

Figure 9. Stability check of the polygonal model (drawing by author).

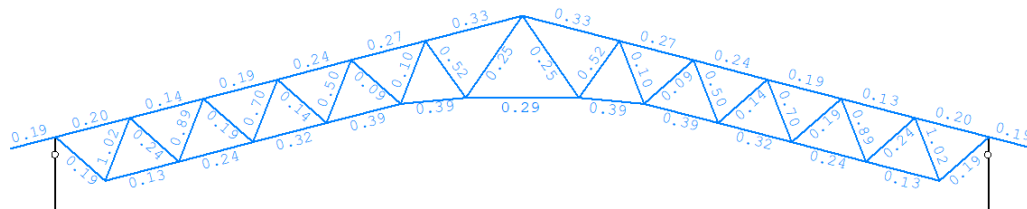
Figure 10. Stability check of the idealized model (drawing by author).

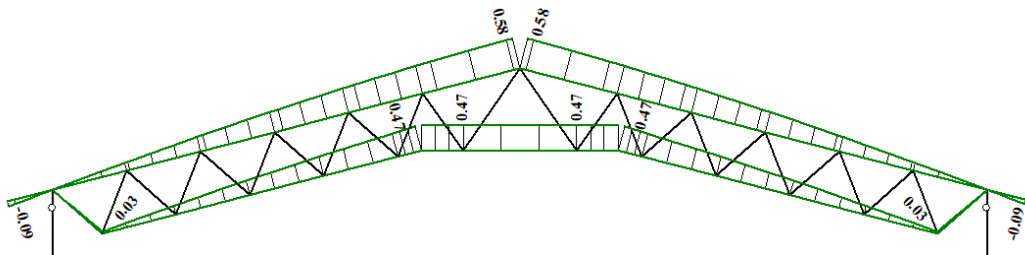
Based on the presented data, it was found that the ambient temperature difference averaged about 10°C when comparing temperatures at 7:00 and 12:00. It was also shown that the top chord of the girder had, on average, a temperature 1.5°C higher than that of the bottom chord. On this basis, computational models were developed in the Tower software, in which temperature effects of 10.0°C were applied to the bottom chord and diagonals in the axes of the cross-sections, and 11.5°C to the axes of the cross-sections of the top chord. Figure 16 shows the calculated deflections of the bottom and top chords of the steel truss.

Figure 16. Truss deflection [mm] due to temperature variations (drawing by author).
