## METHODS FOR STRUCTURAL CONDITION ASSESSMENT AND PROOF LOAD TESTING: A CASE STUDY OF THE CAMPUS GARAGE AT THE UNIVERSITY OF BANJA LUKA

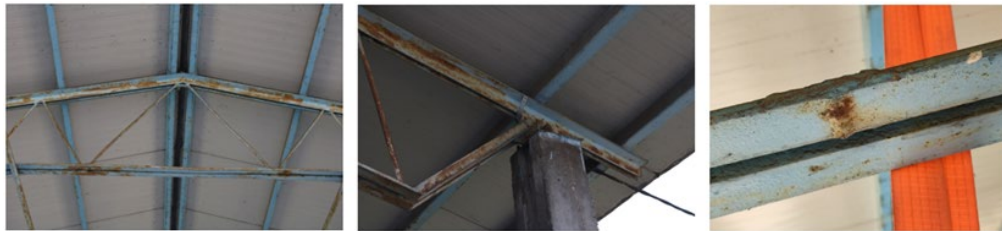
Corrosion observed on the steel members and welded joints, as shown in Figure 2, indicates long-term exposure of the structure to adverse environmental actions and insufficient corrosion protection.

Figure 2. Typical examples of corrosion on steel members and welded joints (photography by author).

A correct and accurate assessment of the condition of a structure subjected to degradation processes represents the foundation of any successful rehabilitation strategy. Based on the identified damage and defects, appropriate rehabilitation measures should be defined for the structure under consideration. These measures may include removal of the damaged concrete cover and its replacement with new material, such as new concrete, repair mortar, or another appropriate repair material. Prior to this, thorough cleaning of corroded reinforcement bars is required, followed by the application of protective treatments to prevent further corrosion development. Similarly, corrosion of steel girders may be removed mechanically or by sandblasting, followed by the application of appropriate corrosion protection systems.

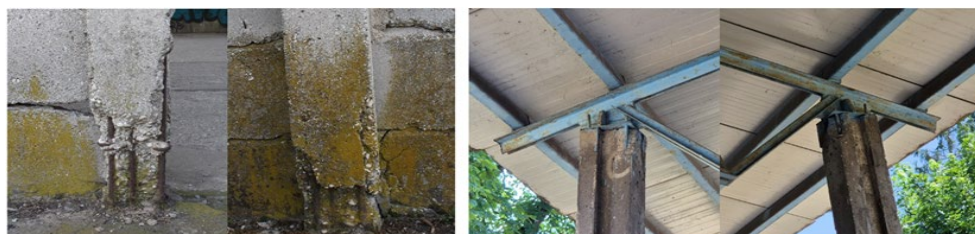
Spalling of the concrete cover was observed on most columns, primarily localized in the lower region of the column and in the upper region near the anchor plate. Inspection revealed that the concrete contained river aggregate with a nominal maximum size of 32 mm. In many locations, insufficient compaction of the concrete is evident, which, after decades of service, has contributed to the observed level of deterioration. The damage in the lower regions of the columns, shown in Figure 3 (left) from the base up to a height of 1.70 m, is additionally attributed to the combined action of frost and de-icing salts, with the latter being introduced via vehicle tires. The deterioration observed in the upper regions of the columns (Figure 3, right) results from the synergistic effects of inadequate concrete compaction and mechanical actions induced by the operation of the anchors under various service conditions. Localized concrete detachment was typically observed around one to two anchors.

Figure 3. Spalling of concrete cover in column lower zones (left) and upper zones near the anchor plate (right) (photography by author).

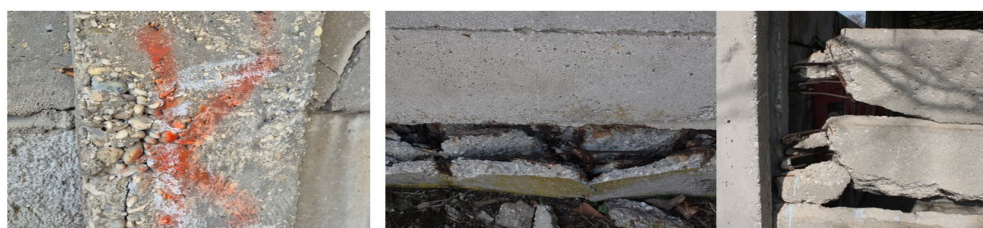
Significant concrete segregation was observed in several locations (Figure 4, left), with a complete absence of cement paste in zones extending up to half of the column width. At these locations, a local reduction in concrete strength of over 40% is estimated [2].

Non-structural parts of the structure – the parapet walls were severely damaged at numerous locations. Characteristic examples are shown in Figure 4 (right). Large portions of concrete were detached, the reinforcing steel was exposed and corroded, and vegetation growth was observed on the exterior surfaces of the walls.

Figure 4. Segregation of concrete in the columns (left) and deterioration of non-structural elements (parapet walls) (right) (photography by author).

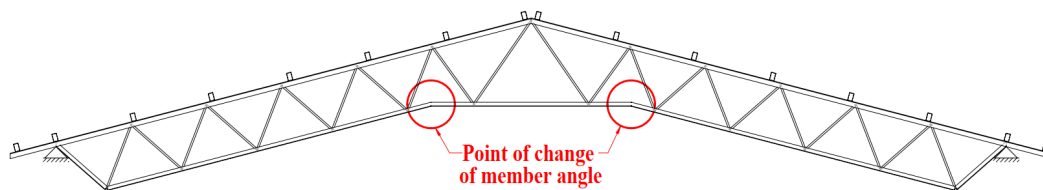
At the time when the project was executed, the design calculations of structural elements were carried out using simplified procedures (without the application of advanced software tools that are commonly used in current engineering practice). This indicates that the analysis of the truss girders was performed using a model composed of straight bar elements with concentrated loads applied at the joints. However, during the construction phase, deviations from the design model occurred, and the girders were executed with a different geometry, as shown in Figure 5.

Figure 5. Polygonal configuration of the lower chord of the main truss girder (drawing by author).

In the continuation of the study, the actual (polygonal) structural model is analyzed, which was found not to satisfy the load-bearing capacity criteria for the design loads according to the JUS regulations. This result indicates the need for a more detailed analysis in order to explain how the structure has successfully withstood significant loads during service, particularly snow loads, which on several occasions exceeded the design values (a characteristic example being the snow load recorded in December 2024).

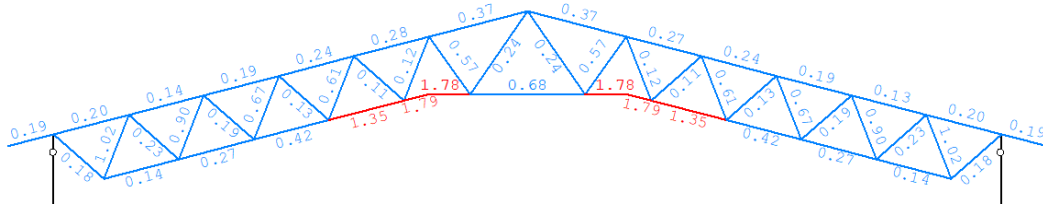
Figures 9 and 10 present the results of the stability check (without reduction of the allowable stress) for the polygonal and idealized models, respectively. Members of the lower chord of the polygonal model whose bending moments induced significant stresses exceeding the allowable values are marked in red. It was established that these members satisfy the stability criteria for the combination of permanent load plus 44% of the snow load.

Figure 9. Stability check of the polygonal model (drawing by author).

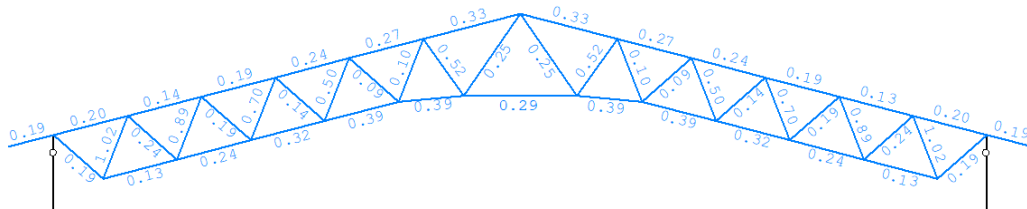
Figure 10. Stability check of the idealized model (drawing by author).

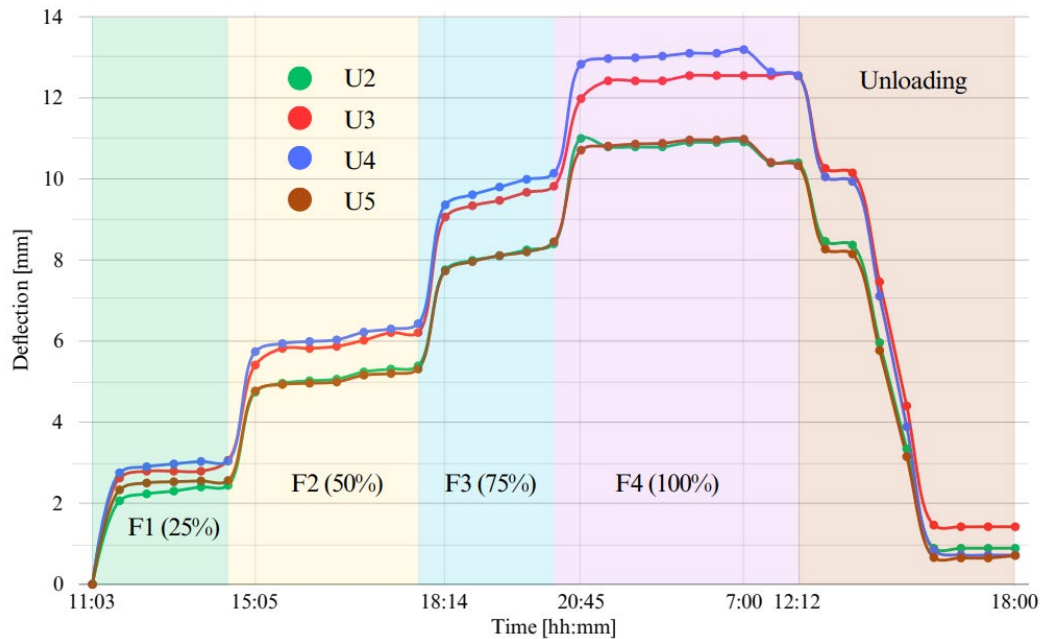
Figure 14 shows the variation of deflection values at measurement points U2, U3, U4, and U5 over the duration of the test. Measurement point U1 is omitted, as it did not exhibit any increase in deflection.

Figure 14. Measured deflections [mm] as a function of time for measurement points U2, U3, U4, and U5 (drawing by author).

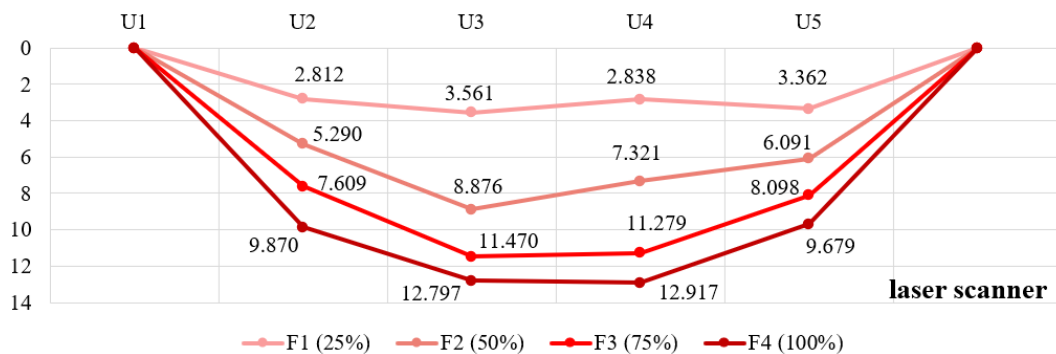
Figure 15. Deflections [mm] measured by the terrestrial laser scanner (drawing by author).

Based on the presented data, it can be concluded that the final deflection values measured by the scanner do not differ by more than 6.3% compared to the results obtained using mechanical dial gauges. Particularly good agreement was observed at measurement points U3 and U4, where the deviations do not exceed 3%. The maximum absolute deviation amounts to 2.666 mm, recorded at measurement point U3 during loading phase F2, which is still within the stated scanner accuracy of  $\pm 3$  mm.

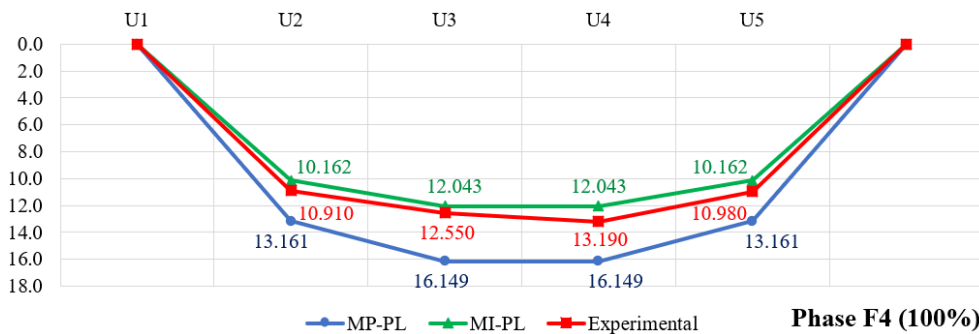
Figure 20. Theoretical and experimental deflection values [mm] for load testing phase F4 (100%) (drawing by author).
