LASER SCANNING AT THE LOCATION OF DEVILS' TOWN FOR THE PURPOSE OF DETECTING THE DEGREE OF EROSION OF EARTH PILLARS

Abstract

The detection of erosion was carried out on a characteristic rocky pillar, with the localization and quantification of differences between two surfaces. For this purpose, based on the defined area and spatial configuration of the scanning object, scanner positions, arrangement of control points, and appropriate spatial scanning resolution were planned. The spatial resolution of the point cloud is 1 cm, with a standard deviation of individual points up to 3 mm. Based on the collected data, registration of adjacent scenes was performed using typical scanner signals and the surface matching method. Georeferencing of the second epoch was carried out using the surface matching method. Locations where erosion of the rocky mass occurred were detected, amounting to 0.036 m³ (36 dm³).

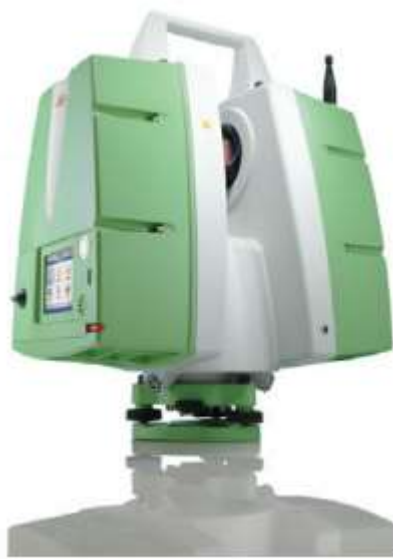
Figure 3. Leica Scan Station P20 [13]

During scanning, the Leica Scan Station P20 scanner was used (Figure 3). The combination of pulsed time-of-flight distance measurement with Waveform Digitizing (WFD) technology enables high scanning speeds with the Leica P20 scanner (1,000,000 points/s), as well as the capability of distance measurement (up to 120 m), justifying the choice of this scanner to survey the Devils' town site. The declared accuracy of this scanner is 3 mm at 50 m. The laser belongs to Class 2, with a wavelength range from 658 nm (visible) to 808 nm (invisible). The ideal operating temperatures for this scanner range from -20°C to $+50^{\circ}\text{C}$ [13].

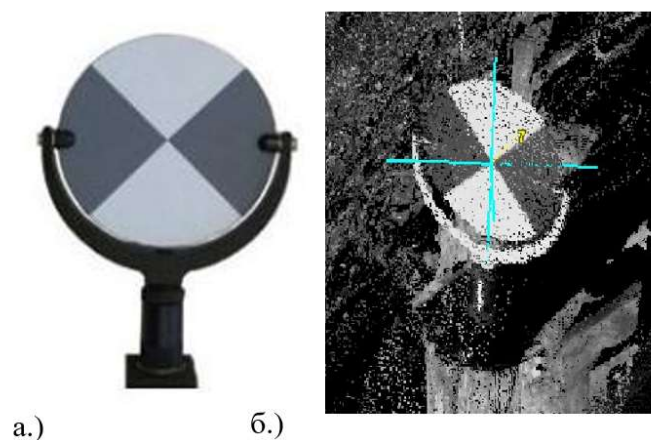
Figure 4. a.) Leica standard target b.) Appearance of scanned signal

As accompanying equipment for materializing tie points for registration purposes, Leica standard targets shown in Figure 4 were used.

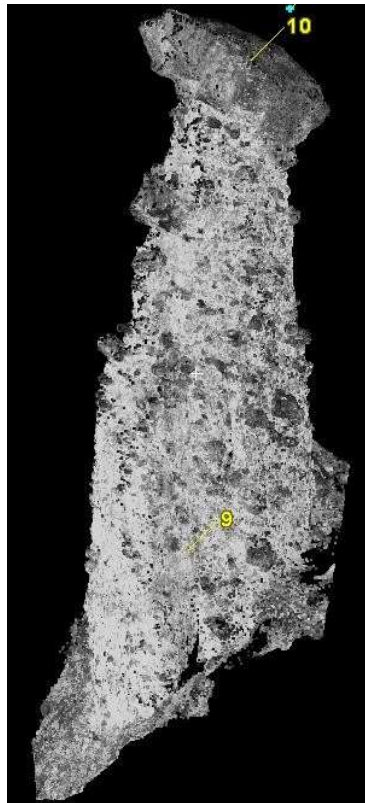
Figure 7. The pillar "Barjaktar" after extraction

After georeferencing the point cloud of the entire site for both recording epochs, the pillar of interest ("Barjaktar") was "cut out" (Figure 8), and the point cloud resolution was adjusted to 1 cm (using the *Unifi cloud* function) to enable the comparison of two georeferenced point clouds of the same pillar, captured in two epochs.

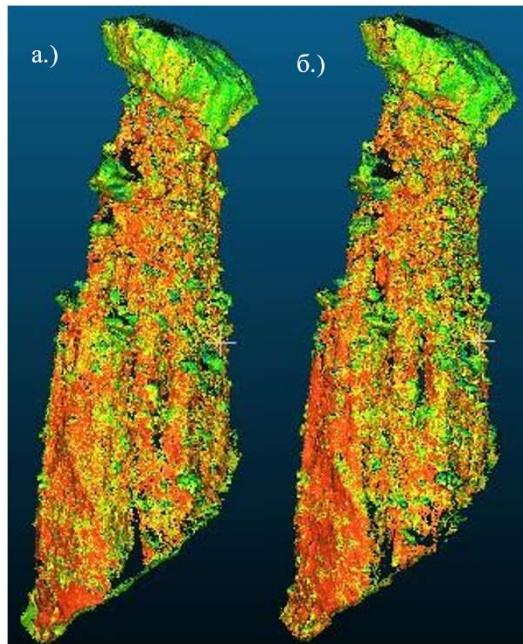
Figure 8. The pillar of "Barjaktar" a) first epoch b) second epoch

For the next analysis, the CloudCompare software [15] (an open-source program) was used. Figure 8 shows the point clouds from the first and second epochs within this program.

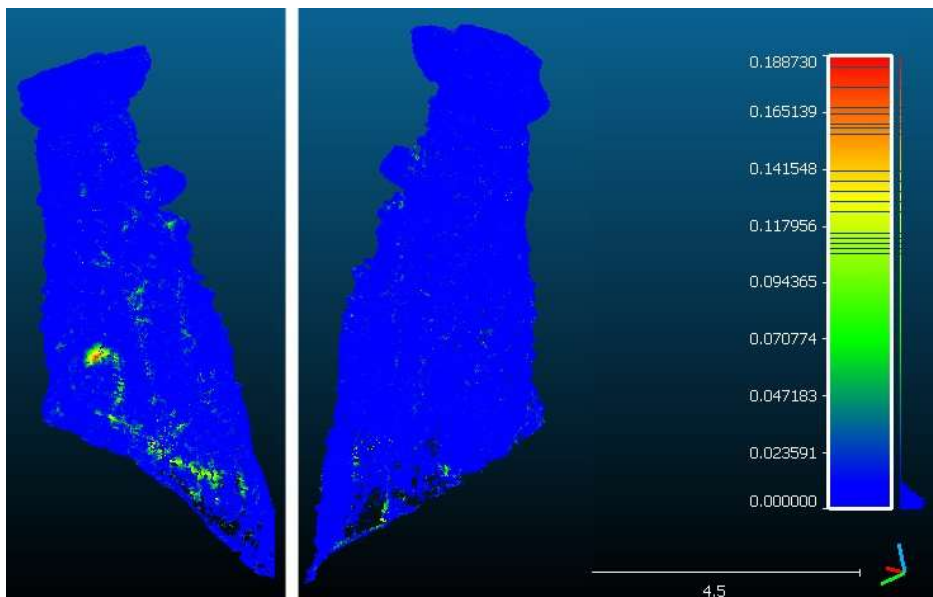
Figure 9. The result of comparing the first and second epochs

After loading both point clouds, the next step involves computing deviations between the two epochs. The Cloud/Cloud Distance function was used for this step. The point cloud from the first epoch serves as the reference for comparison, while the point cloud from the second epoch is the one being compared. The basic idea is to determine distances using the nearest neighbor distance method. Calculating distances using the nearest neighbor method sometimes isn't precise enough if the point cloud isn't dense enough or has gaps. Increasing precision can be achieved by defining local models. When comparing point clouds of interest, the local Height Function model was employed. This choice was made based on the recommendation of the program creators, particularly when dealing with point clouds exhibiting "high curvature" [15]. The result of comparing the two epochs is shown in Figure 9. The figure displays a color scale representing the distance between the epochs.

Visual inspection and comparison were conducted on areas marked by the color scale ranging from green to red, indicating areas where erosion occurred. As seen in Figure 10, there are areas where

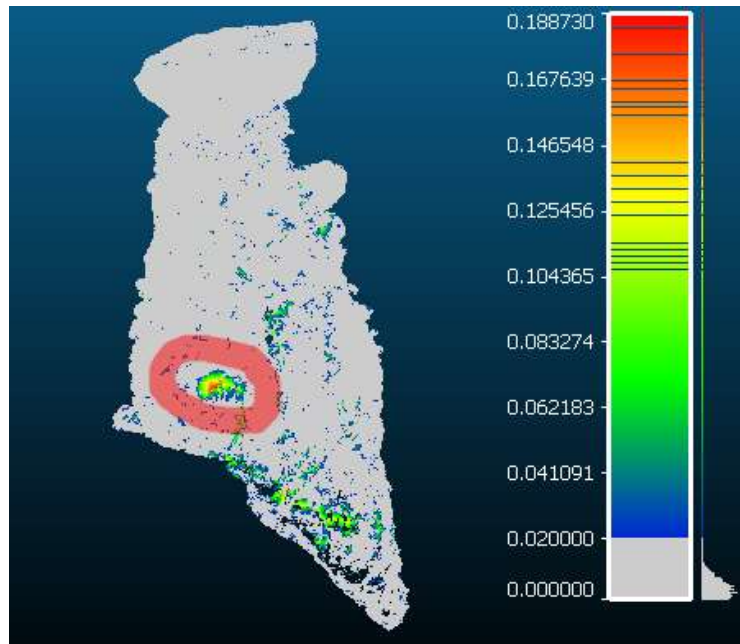
Figure 10. The area (outlined in red) where erosion has occurred

erosion has occurred, while the appearance in other places is due to the lack of points from the first recording epoch. These areas were not further considered. The area where erosion occurred is shown in Figure 10 and will be the subject of further consideration.

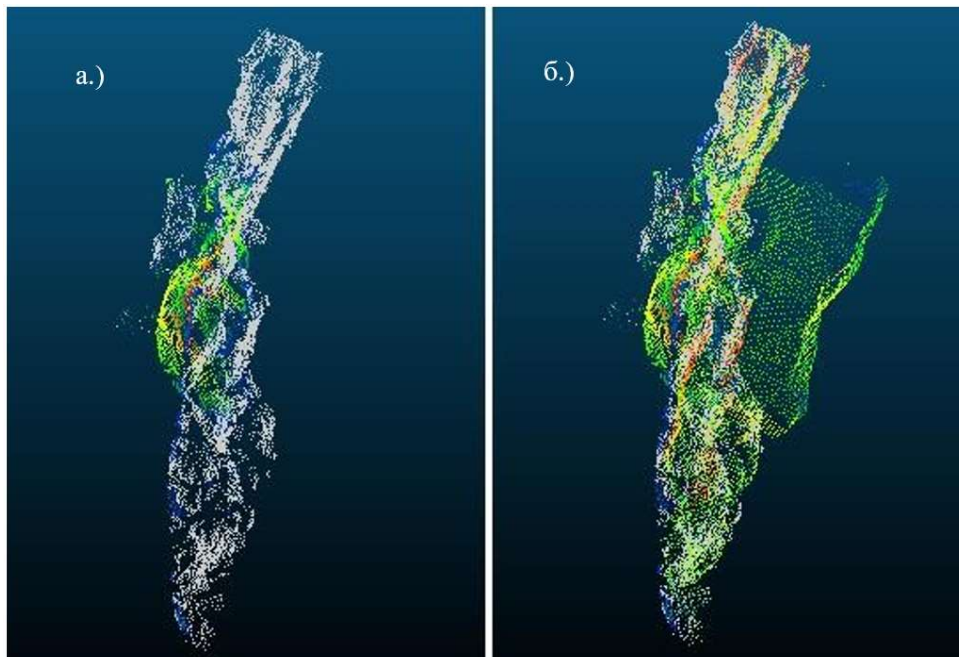
Figure 11. a) Point cloud from the second epoch. b) Point cloud with the first epoch included.

The area of interest has been isolated from the point cloud, and an analysis has been conducted on it. Figure 11 shows the area where the analysis was conducted. One part of the image displays the point cloud from the second epoch, while the other part shows the point cloud where the first epoch recording is also depicted. It is evident here that there was a significantly more rocky mass in the first epoch compared to the second.
