Anastasija Martinenko, University of Belgrade, amartinenko@grf.bg.ac.rs
Marko Pejić, University of Belgrade, mpejic@grf.bg.ac.rs

LASER SCANNING AT THE LOCATION OF DEVILS' TOWN FOR THE PURPOSE OF DETECTING THE DEGREE OF EROSION OF EARTH PILLARS

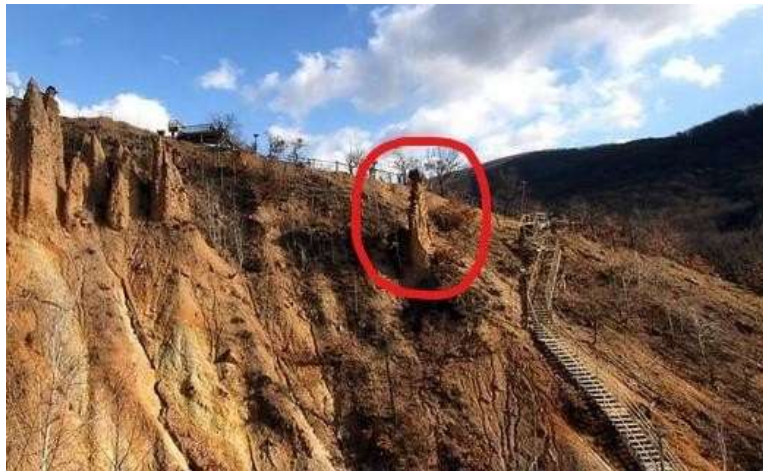
Figure 2. Position of "Barjaktar"

The task of this study is the detection of erosion on characteristic rocky pillars. The pillar whose analysis is presented in this paper is the "Barjaktar" pillar (Figure 2). The name "Barjaktar" comes from the legend associated with "Devils' town", which states that the rocky pillars are petrified wedding guests. "Barjaktar," as the most prominent pillar, has an andesite cap weighing around 3.4 t [7].

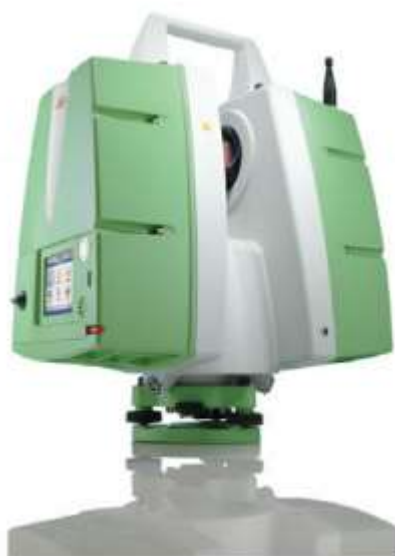
Figure 3. Leica Scan Station P20 [13]

During scanning, the Leica Scan Station P20 scanner was used (Figure 3). The combination of pulsed time-of-flight distance measurement with Waveform Digitizing (WFD) technology enables high scanning speeds with the Leica P20 scanner (1,000,000 points/s), as well as the capability of distance measurement (up to 120 m), justifying the choice of this scanner to survey the Devils' town site. The declared accuracy of this scanner is 3 mm at 50 m. The laser belongs to Class 2, with a wavelength range from 658 nm (visible) to 808 nm (invisible). The ideal operating temperatures for this scanner range from -20°C to $+50^{\circ}\text{C}$ [13].
