Jasna Grujoska-Kuneska, International Balkan University, [jasna.kuneska@ibu.edu.mk](mailto:jasna.kuneska@ibu.edu.mk)  
Veronika Shendova, Institute of Earthquake Engineering and Engineering Seismology (IZIIS),  
[veronika@iziis.ukim.edu.mk](mailto:veronika@iziis.ukim.edu.mk)

## A NON-DESTRUCTIVE APPROACH TO THE SUSTAINABLE CONSERVATION OF BUILT HERITAGE

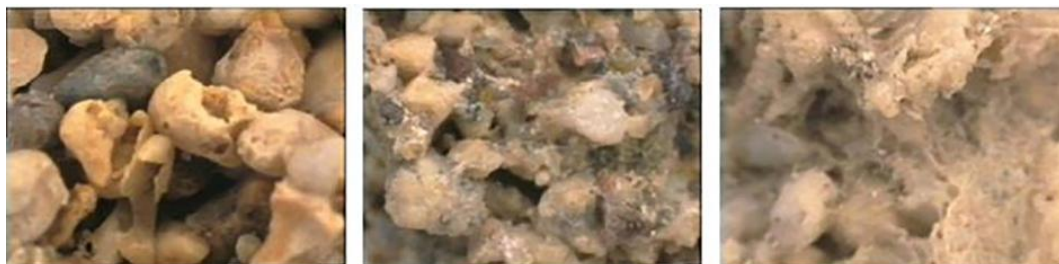
*Figure 1. Fiber optic images from consolidation interventions (x50), untreated porous stone (left), treated porous stone with different consolidants (middle and right) [10].*

Figure 1 shows the microstructure of porous stone before and after the treatment with different consolidation agents. The application of the microscope provides a clear insight into the distribution of the consolidant and the changes at the microstructural level [10].

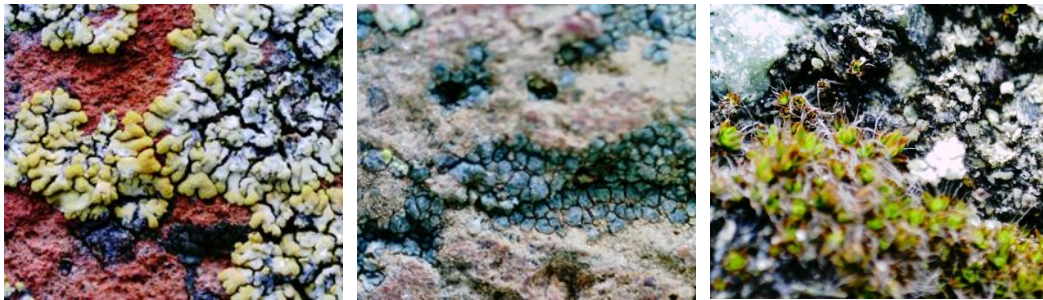
Figure 6. Different types of lichens present on facade surfaces (microscopic images, magnification x 40) [47].

To evaluate the condition of the church and its preservation state a detailed survey was conducted in the period 2021-2024. This survey comprised archival research, documentation review and on-site inspections, including several NDTs: digital microscopy, infrared thermography, 3D laser scanning and ambient vibration tests [47]. The review of the available documentation enabled insight into the historical context of the church, including different historical phases and previous interventions. On-site inspections involved examination of the facades and interior of the church. The facade inspections revealed the good condition of the surface materials but also pointed out to certain irregularities such as: pronounced porosity of the limestone and carbonation of the lime mortar; presence of capillary moisture in the lower zones of the north and west walls; bio colonization in the lower and middle zones of all facades. Additionally, the use of a digital microscope provided more detailed investigation of certain surfaces, i.e. identification of the present

bio organisms - several species of lichens (fig. 6), identification of micro cracks and investigation of the morphological characteristics of the different types of façade stones. Certain minor cracks were observed in the upper zones of the church's interior and a disruption in one of the wooden ties.
