Jasna Grujoska-Kuneska, International Balkan University, [jasna.kuneska@ibu.edu.mk](mailto:jasna.kuneska@ibu.edu.mk)  
Veronika Shendova, Institute of Earthquake Engineering and Engineering Seismology (IZIIS),  
[veronika@iziis.ukim.edu.mk](mailto:veronika@iziis.ukim.edu.mk)

## A NON-DESTRUCTIVE APPROACH TO THE SUSTAINABLE CONSERVATION OF BUILT HERITAGE

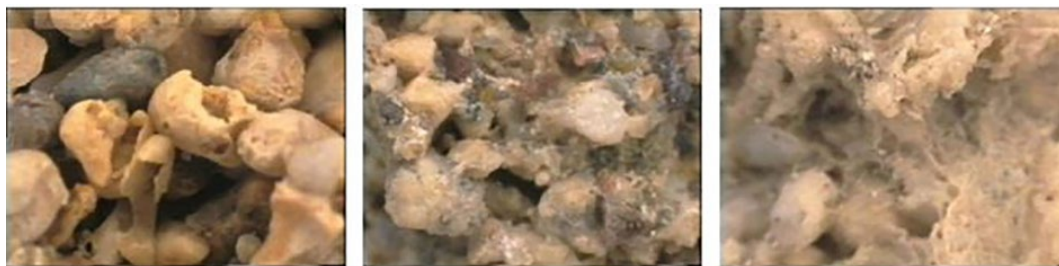
Figure 1 shows the microstructure of porous stone before and after the treatment with different consolidation agents. The application of the microscope provides a clear insight into the distribution of the consolidant and the changes at the microstructural level [10].

*Figure 1. Fiber optic images from consolidation interventions (x50), untreated porous stone (left), treated porous stone with different consolidants (middle and right) [10].*

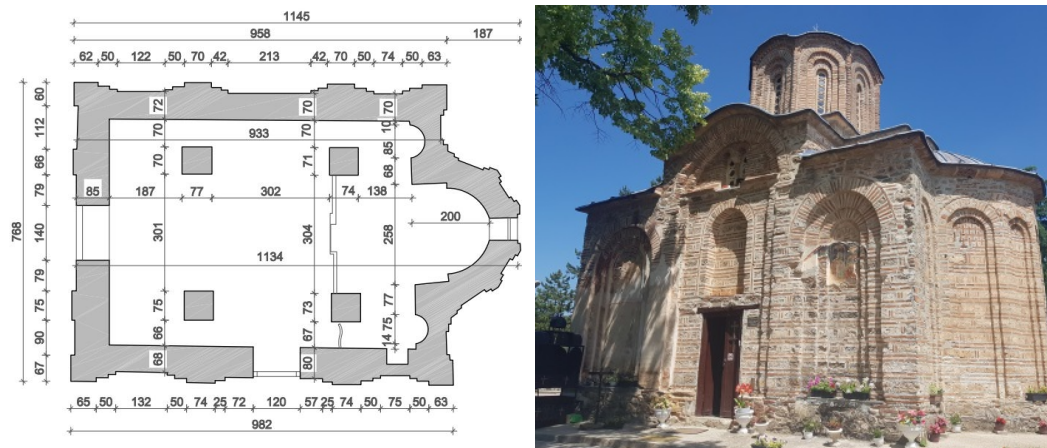
The Church of St. Nikita is a typical late Byzantine monument from the 14th century, located in the village of Banjani, near the capital, Skopje. Typologically, this church belongs to the domed cross-in-square buildings, which is the predominant type of c Byzantine style church in the Republic of North Macedonia. In the base of the church there are two clearly defined areas: a central nave and an altar area that ends with a five-sided apse to the east, figure 5. The main structural elements are made of stone and brick, connected with lime mortar [47], [48].

Figure 5. Church of St. Nikita, floor plan (left), south-east view (right) [47].

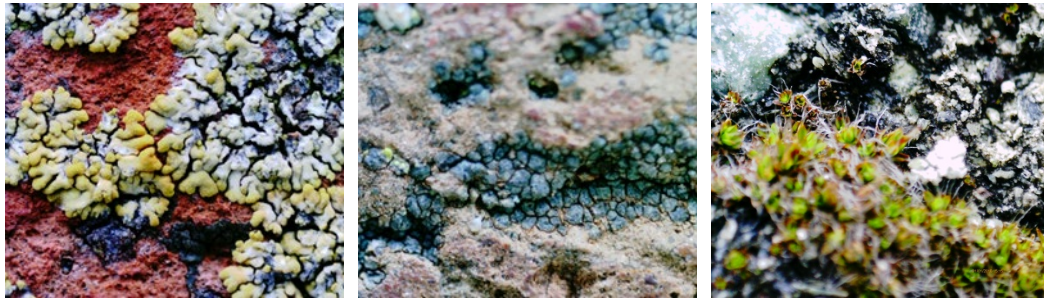
microscope provided more detailed investigation of certain surfaces, i.e. identification of the present bio organisms - several species of lichens (fig. 6), identification of micro cracks and investigation of the morphological characteristics of the different types of façade stones. Certain minor cracks were observed in the upper zones of the church's interior and a disruption in one of the wooden ties.

Figure 6. Different types of lichens present on facade surfaces (microscopic images, magnification x 40) [47].
