## CONSTRUCTION OF THE IBARAC TUNNEL AS PART OF THE ROŽAJE BYPASS PROJECT IN MONTENEGRO

The Ibarac tunnel was excavated as part of the Rožaje bypass project in Montenegro. Nearly half of the excavation was carried out in glaciofluvial sediments consisting of brown sandy clay with gravel and rock fragments. As the original design did not anticipate tunneling through such deposits, the subsequent adoption of overly optimistic geotechnical parameters led to several collapses during the construction phase. A major collapse occurred within a section containing a parking niche at km 0+473. Although the overburden at this location exceeded 100 m, deformations reached the surface, forming a vertical channel with a diameter of 26 m. This paper proposes a rehabilitation solution using a pre-grouting technique.

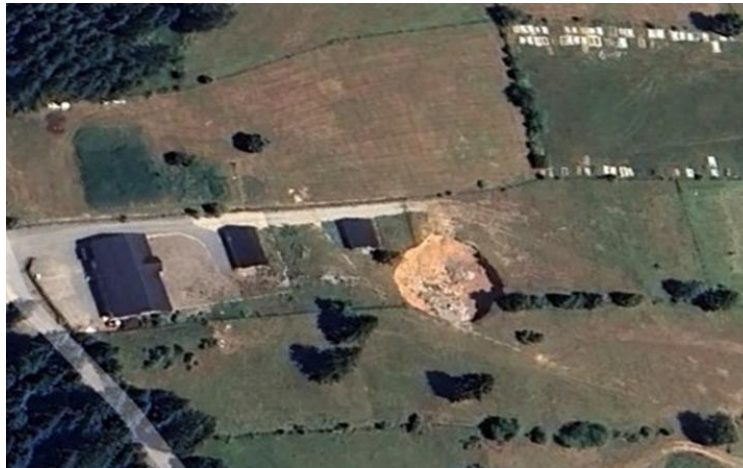
Rehabilitation of the primary support progressed until km 0+473, when the collapse of the double pipe roofs occurred. This structural failure made further top-heading excavation impossible, and progress was halted. Soon there was a large influx of underground water and then the tunnel collapsed. The material filled 40 m of the tunnel tube, forming a vertical channel 100 m high to the surface, where a crater with a diameter of 26 m was formed, Figure 1.

*Figure 1. Crater on the surface of the terrain as a result of the collapse in tunnel (photography by author).*

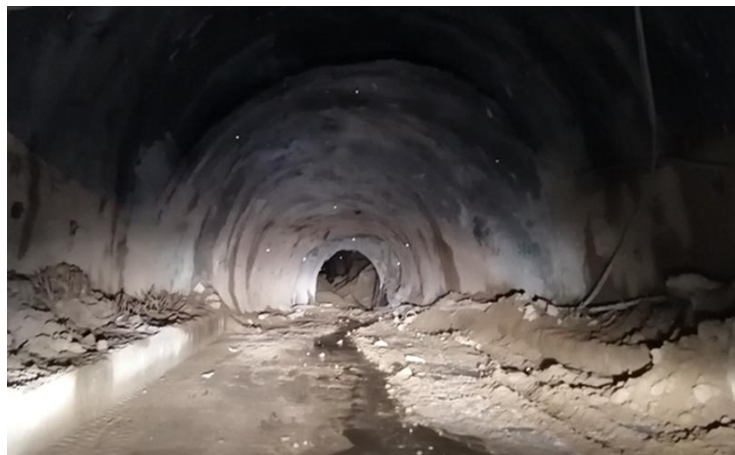
Reservations were raised regarding the proposed rehabilitation strategy, as a fully formation of a load bearing ring around the tunnel could no longer be guaranteed following such a large collapse. Despite this, during initial rehabilitation efforts, the contractor successfully established a connection through the collapsed zone using a reduced excavation profile. The pilot tunnel ensured free groundwater flow and reduced ground pressure. As shown in Figure 2, the reduced profile was stabilized with lattice girders, reinforcing mesh, shotcrete, and anchors. However, works were soon suspended due to a lack of funding.

*Figure 2. Reduced profile, through the collapsed material of the Ibarac tunnel (photography by author).*

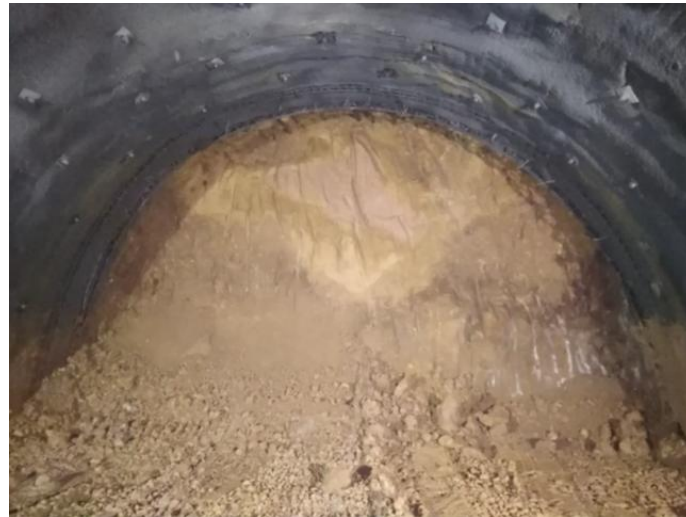
While primary support was installed along nearly the entire length of the Ibarac tunnel, excavation was hampered by several major collapses. Investigating the root cause of the deformations following support installation is critical. Although the glaciofluvial sediments initially appeared stable, Figure 3, it is evident that their geotechnical parameters were overestimated and that a temporary footing arch should have been systematically implemented. Nevertheless, the weakened tunnel subgrade remained stable until the ingress of groundwater. This groundwater influx not only exerted additional hydraulic pressure but also triggered the leaching of fine particles, ultimately compromising the soil skeleton and leading to instability.

Figure 3. Tunnel face in glaciofluvial sediments, Ibarac tunnel (photography by author).
