## STRUCTURAL VULNERABILITY ASSESSMENT OF AN HISTORICAL MASONRY BUILDING – CASE STUDY

This paper presents a vulnerability assessment of an historical masonry building representative of early 20th-century construction. The structure consists of load-bearing masonry walls with timber floors and lacks seismic detailing. The methodology included visual inspection, typological classification and simplified control analysis. Observed damage includes masonry cracking, mortar degradation, timber floor deflections and local foundation settlements. The assessment indicates insufficient global structural integrity and pronounced vulnerability typical of historical unreinforced masonry buildings. The results support decision-making regarding strengthening or demolition of severely degraded masonry structures.

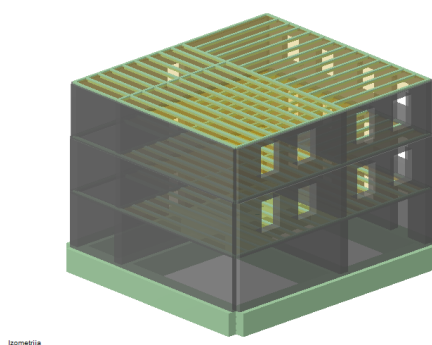
As part of this analysis, a control static calculation was also performed, for comparison with the on-site condition. Primarily, attention was paid to the seismic analysis of the building. The calculation showed the irregularity of the building's construction even during the modal analysis itself. Most of the first tones show a local type of oscillation of the building's elements, i.e. the walls of the building are the first to enter the oscillation phase, which would result in their lateral overturning and falling out [1], [7]. Only at higher tones did the building as a whole begin to oscillate. Such dynamic behavior indicates a high probability of local wall failure and potential progressive collapse under seismic excitation [1], [7], as shown on Fig. 6, 7, 8 and 9.

Figure 6. Static calculation - Isometric view of the model (drawing by author).
