## METHODS FOR STRUCTURAL CONDITION ASSESSMENT AND PROOF LOAD TESTING: A CASE STUDY OF THE CAMPUS GARAGE AT THE UNIVERSITY OF BANJA LUKA

This paper presents a comprehensive condition assessment of the campus garage at the University of Banja Luka. The assessment methodology included visual inspections, non-destructive testing (NDT) of concrete using rebound hammer and ultrasonic pulse velocity methods, and proof load testing of the primary roof truss. Deformations were monitored using dial gauges, deformeters, and geodetic instruments, specifically laser scanning and digital levels. Numerical modeling was conducted to determine the theoretical deflections of the roof truss, with particular emphasis on the specific characteristics of the bottom chord. The key contribution of this work lies in the comparative analysis of results obtained through different methods and measuring devices. This study aims to enhance the condition assessment of similar structures and provide a framework for the future Code of Practice for Structural Assessment in the Republic of Srpska.

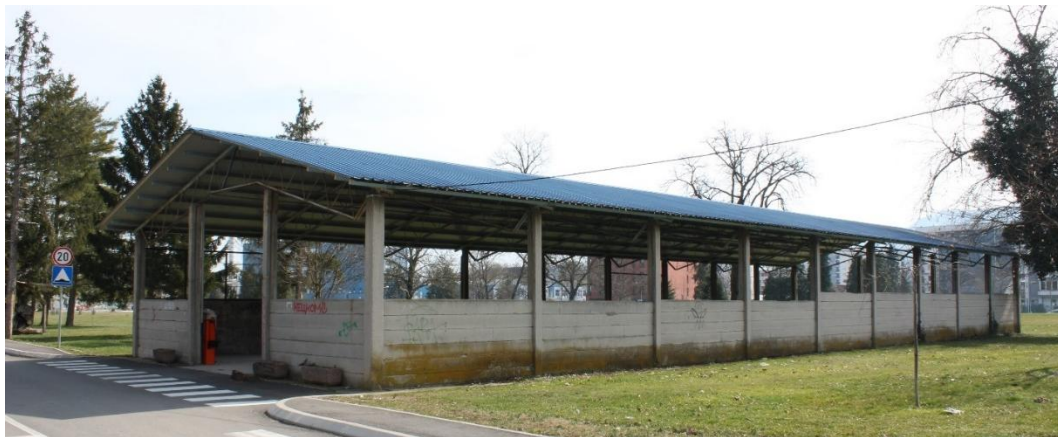
Figure 1. "Campus garage" at the University of Banja Luka (photography by author).

The estimated age of the structure is approximately 55 years. The structure has a regular rectangular plan with overall dimensions of  $12 \times 36$  m. The roof covering consists of 5 cm thick sandwich panels. The roof covering is supported by steel purlins made of rectangular hollow sections (RHS)  $100 \times 60 \times 3$  mm, spaced at a center-to-center distance of 102 cm. According to the static system, the purlins act as simply supported beams resting on the main steel truss girders. The primary load-bearing structure consists of ten transverse frames spaced at 4 m intervals. The upper chord of the steel truss is composed of two equal-leg angle sections  $L 65 \times 65 \times 7$  mm with a spacing of 22 mm, while the lower chord consists of two equal-leg angle sections  $L 50 \times 50 \times 5$  mm with the same spacing. The truss web consists of diagonal members formed by bending reinforcing bars with a diameter of 22 mm. The diagonals are welded to the upper and lower chords of the truss. The connection between the truss and the column is pinned, realized by means of a bearing steel plate with stiffening plates and four anchor bolts. The vertical load-bearing structure consists of reinforced concrete columns with an I-shaped cross-section, with overall dimensions of  $18.5 \times 25.5$  cm.

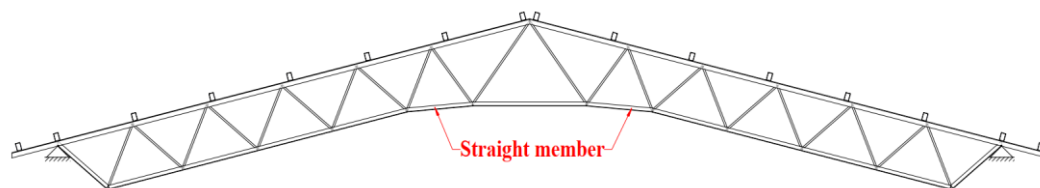
Plasticization of the main girder was observed in all girders except the two end girders. This can be explained by the fact that the end girders were subjected to approximately half of the load during service, and therefore did not undergo the above-mentioned plastic behavior.

Due to the previously described irregularities, an alternative, idealized calculation model of the main truss girder is introduced in this paper, as shown in Figure 6.

Figure 6. Idealized model of the main truss girder (drawing by author).

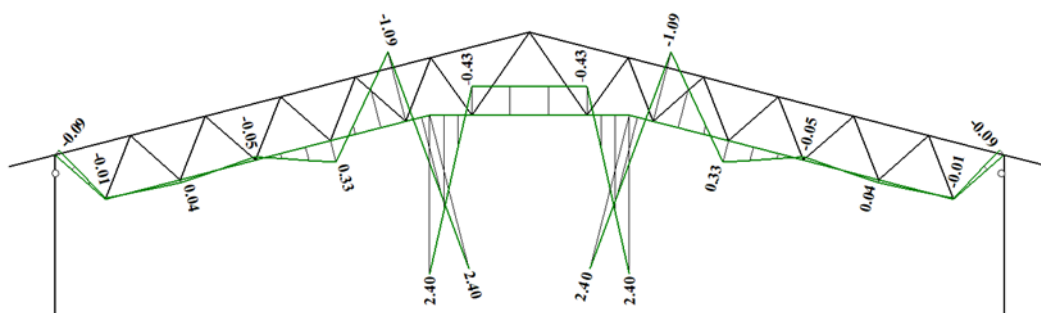
Figures 7 and 8 show the bending moments for the fourth phase of testing (100% of the snow load) for the polygonal and idealized models, respectively. Corrosion of steel elements detected during the visual inspection was not taken into account in the evaluation of the load-bearing capacity of the steel truss, as its influence was considered negligible.

Figure 7. **MP-PL** Bending moments of the bottom chord of the main girder [kNm] for Phase F4 (drawing by author).

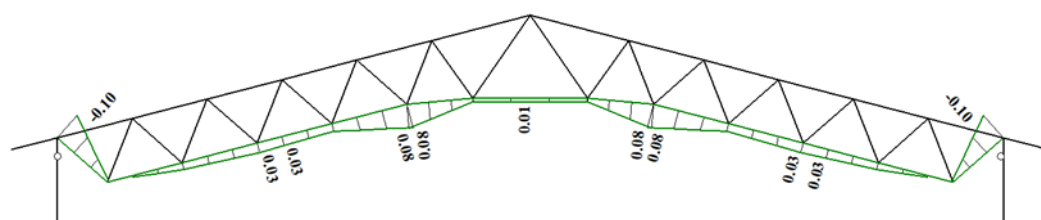
Figure 8. **MI-PL** Bending moments of the bottom chord of the main girder [kNm] for Phase F4 (drawing by author).

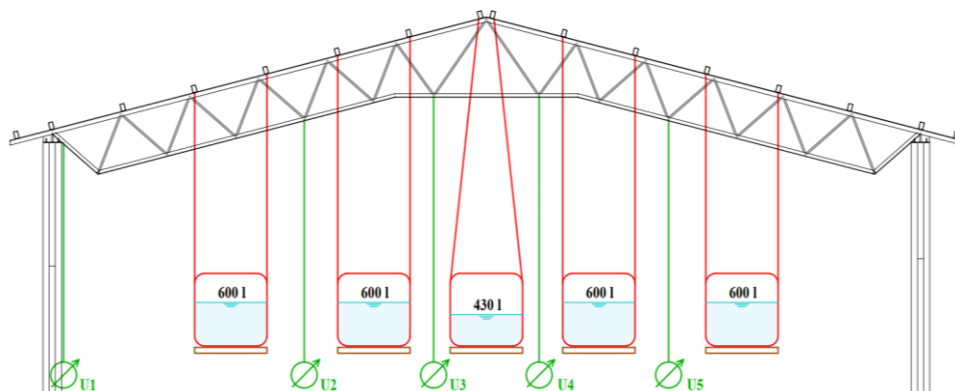
One day prior to the test, the structure was prepared. For the girder subjected to testing, five plastic tanks with corresponding pallets were suspended in accordance with the scheme shown in Figure 11. Each tank had a capacity of 1000 l, which corresponds to a load of 10 kN when the tank is filled with water.

- five mechanical dial gauges of the “Huggenberger” brand, with a measuring range of 0–5 cm and an accuracy of 0.05 mm, for monitoring deflections (vertical displacements) of the girder, installed according to the scheme shown in Figure 11;

Figure 11. Scheme of proof load for the fourth testing phase (100% load) and arrangement of mechanical dial gauges and leveling measurement points (drawing by author).

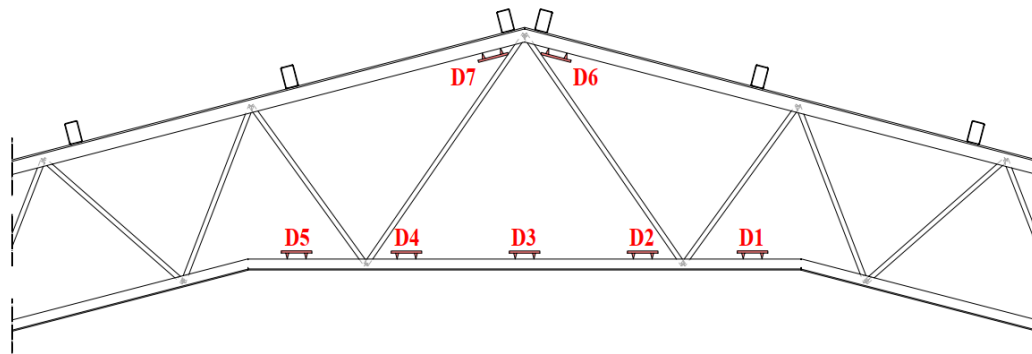
- seven deflectometers of the “Meixin” brand, with a measuring range of 0–1 mm and an accuracy of 0.001 mm, for monitoring relative elongations/shortenings of the bottom and top chords of the truss, installed according to the scheme shown in Figure 12;

Figure 12. Arrangement of deflectometers (strain gauges) (drawing by author).

It is assumed that these deviations occurred due to slight displacement of the deflectometer supports, caused by insufficiently secured adhesive, most likely as a consequence of elevated temperatures. Difficult access to the aforementioned measurement points may have further affected the accuracy and reliability of the measurements.

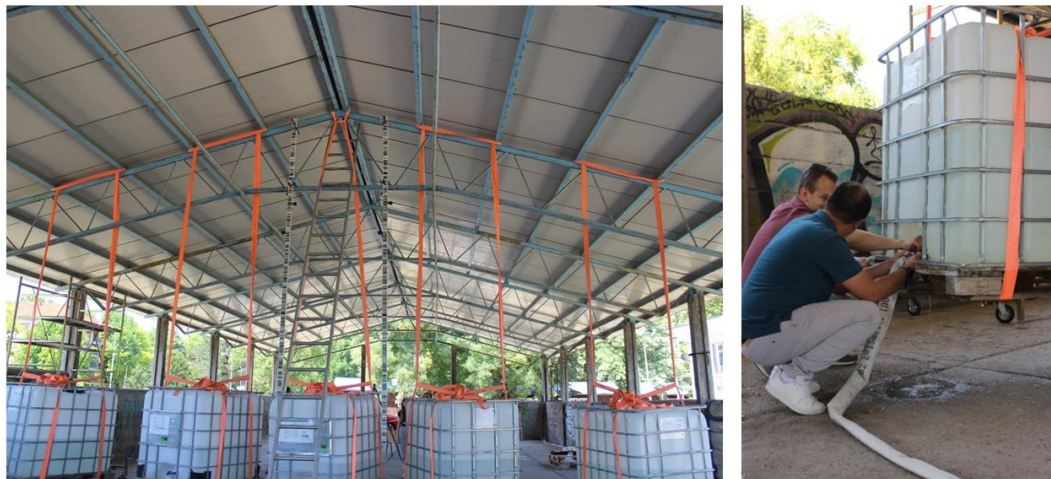
Figure 13. Proof load testing of the 'Campus garage': load application on the steel truss (left) and container unloading (right) (photography by author).

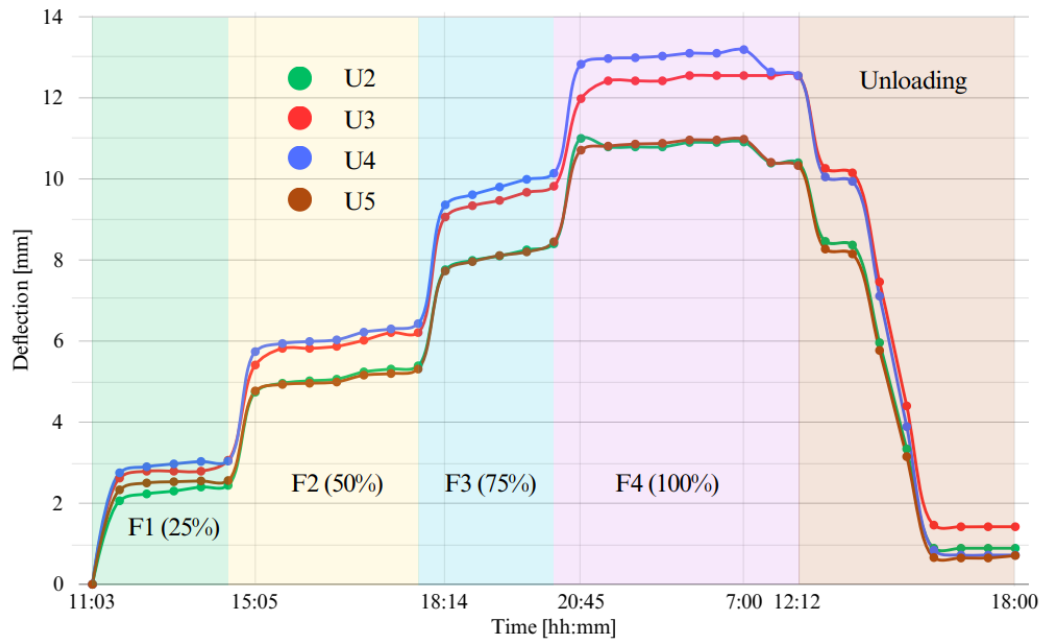
Figure 14 shows the variation of deflection values at measurement points U2, U3, U4, and U5 over the duration of the test. Measurement point U1 is omitted, as it did not exhibit any increase in deflection.

Figure 14. Measured deflections [mm] as a function of time for measurement points U2, U3, U4, and U5 (drawing by author).

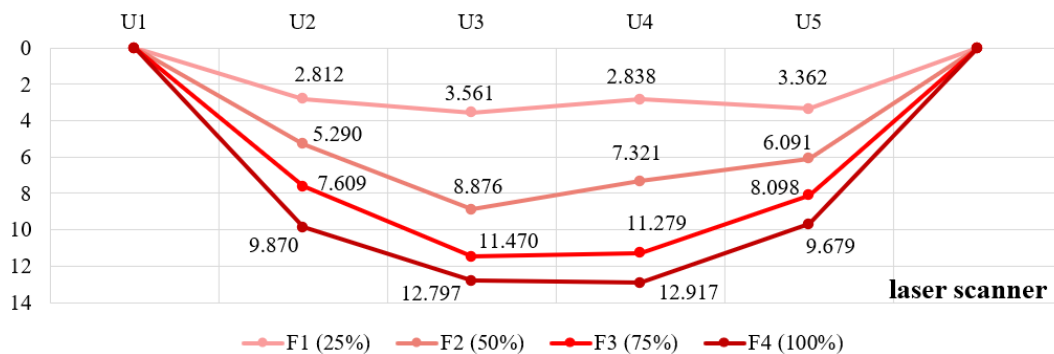
Geodetic scanning was performed to record deformations through the aforementioned four loading phases (Figure 15), with the aim of determining the structural behavior of the girder and comparing the results with the deflection values obtained from deflection gauge measurements.

Figure 15. Deflections [mm] measured by the terrestrial laser scanner (drawing by author).

Based on the presented data, it can be concluded that the final deflection values measured by the scanner do not differ by more than 6.3% compared to the results obtained using mechanical dial gauges. Particularly good agreement was observed at measurement points U3 and U4, where the deviations do not exceed 3%. The maximum absolute deviation amounts to 2.666 mm, recorded at measurement point U3 during loading phase F2, which is still within the stated scanner accuracy of  $\pm 3$  mm.

It is important to note that during the first three loading phases (F1–F3), scanner measurements, which last approximately 30 minutes, were carried out under conditions where the girder was still exhibiting increasing deflections. In contrast, for the final phase (F4), scanning was performed 15 hours after load application, resulting in significantly smaller measurement deviations compared to the previous phases.

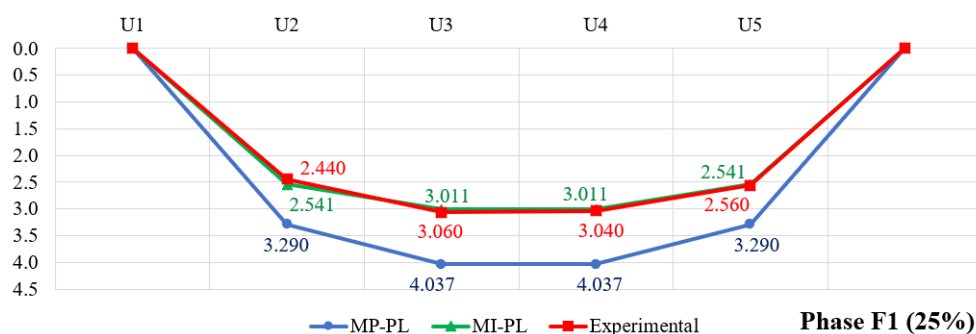
Measurement point U1, located in the support zone of the girder, did not exhibit any deflection during all measurement phases, which is consistent with expectations. This behavior can be explained by the fact that the structure has been in service for approximately 55 years, allowing the ground to fully consolidate. Additionally, no displacement or slip at the support was observed.

Figures 17, 18, 19 and 20 present a comparison between the theoretical and experimental deflection values for load testing phases F1, F2, F3 and F4, respectively.

Figure 17. Theoretical and experimental deflection values [mm] for load testing phase F1 (25%) (drawing by author).

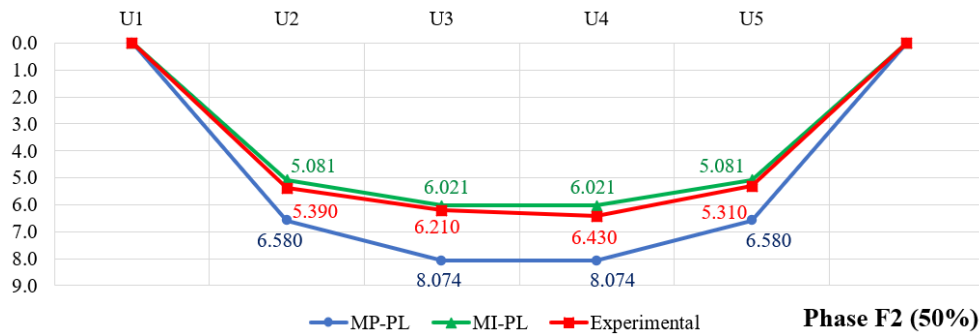
Figure 18. Theoretical and experimental deflection values [mm] for load testing phase F2 (50%) (drawing by author).

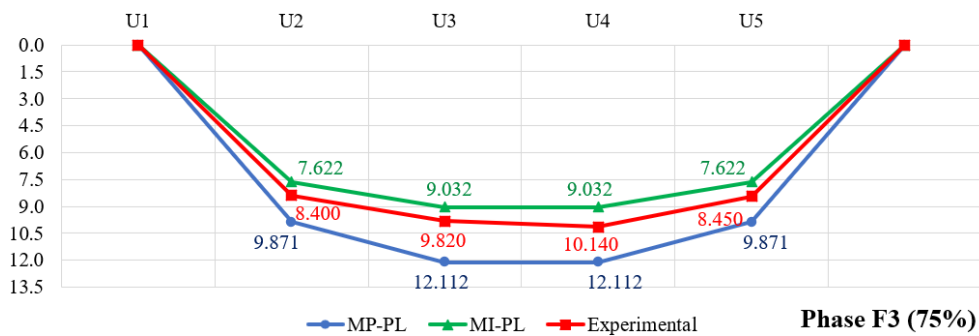
Figure 19. Theoretical and experimental deflection values [mm] for load testing phase F3 (75%) (drawing by author).

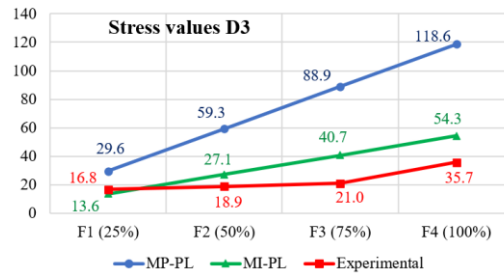
Four measurement points, D1, D2, D4, and D5, were excluded due to evident deviations in the results. The theoretically calculated and experimentally obtained stress values at the remaining

Figure 21. Theoretical and experimental stress values [MPa] at measurement point D3

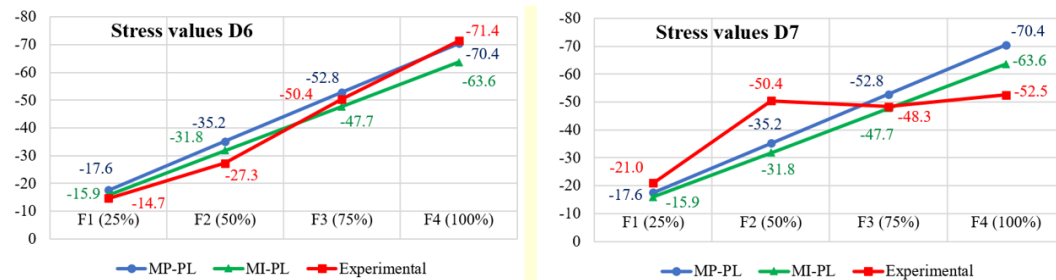
Figure 22. Theoretical and experimental stress values [MPa] at measurement point D6 (left) and D7 (right) (drawing by author).
