## METHODS FOR STRUCTURAL CONDITION ASSESSMENT AND PROOF LOAD TESTING: A CASE STUDY OF THE CAMPUS GARAGE AT THE UNIVERSITY OF BANJA LUKA

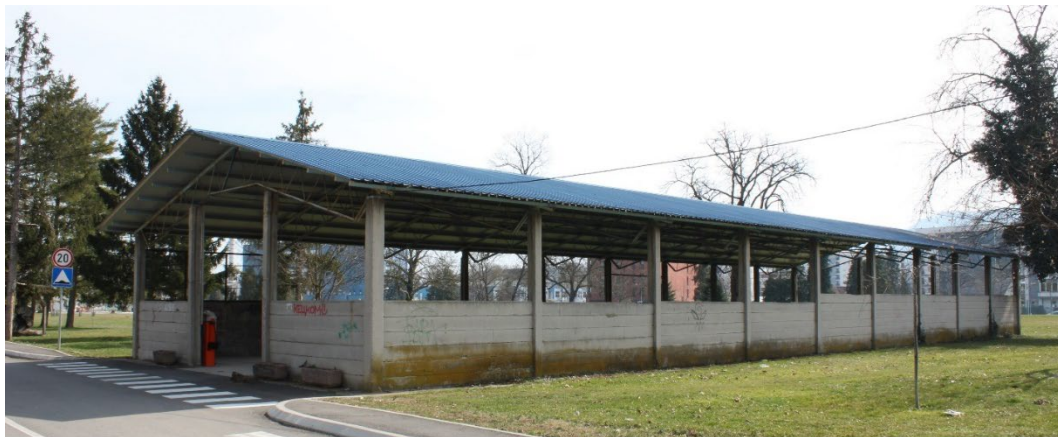
Figure 1. "Campus garage" at the University of Banja Luka (photography by author).

The estimated age of the structure is approximately 55 years. The structure has a regular rectangular plan with overall dimensions of  $12 \times 36$  m. The roof covering consists of 5 cm thick sandwich panels. The roof covering is supported by steel purlins made of rectangular hollow sections (RHS)  $100 \times 60 \times 3$  mm, spaced at a center-to-center distance of 102 cm. According to the static system, the purlins act as simply supported beams resting on the main steel truss girders. The primary load-bearing structure consists of ten transverse frames spaced at 4 m intervals. The upper chord of the steel truss is composed of two equal-leg angle sections  $L 65 \times 65 \times 7$  mm with a spacing of 22 mm, while the lower chord consists of two equal-leg angle sections  $L 50 \times 50 \times 5$  mm with the same spacing. The truss web consists of diagonal members formed by bending reinforcing bars with a diameter of 22 mm. The diagonals are welded to the upper and lower chords of the truss. The connection between the truss and the column is pinned, realized by means of a bearing steel plate with stiffening plates and four anchor bolts. The vertical load-bearing structure consists of reinforced concrete columns with an I-shaped cross-section, with overall dimensions of  $18.5 \times 25.5$  cm.

Based on the overall condition assessment, it can be concluded that the tested structure falls under **Activity level 2**, indicating the need for investment measures to preserve its functionality and structural stability [14].

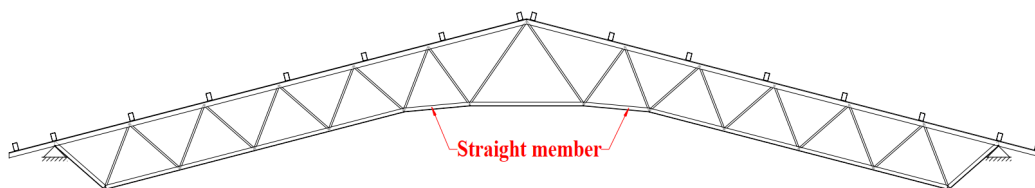
Plasticization of the main girder was observed in all girders except the two end girders. This can be explained by the fact that the end girders were subjected to approximately half of the load during service, and therefore did not undergo the above-mentioned plastic behavior.

Due to the previously described irregularities, an alternative, idealized calculation model of the main truss girder is introduced in this paper, as shown in Figure 6.

Figure 6. Idealized model of the main truss girder (drawing by author).

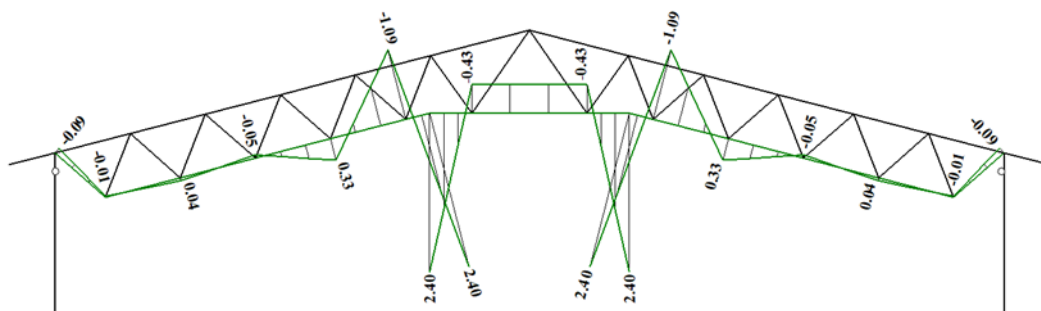
Figures 7 and 8 show the bending moments for the fourth phase of testing (100% of the snow load) for the polygonal and idealized models, respectively. Corrosion of steel elements detected during the visual inspection was not taken into account in the evaluation of the load-bearing capacity of the steel truss, as its influence was considered negligible.

Figure 7. **MP-PL** Bending moments of the bottom chord of the main girder [kNm] for Phase F4 (drawing by author).

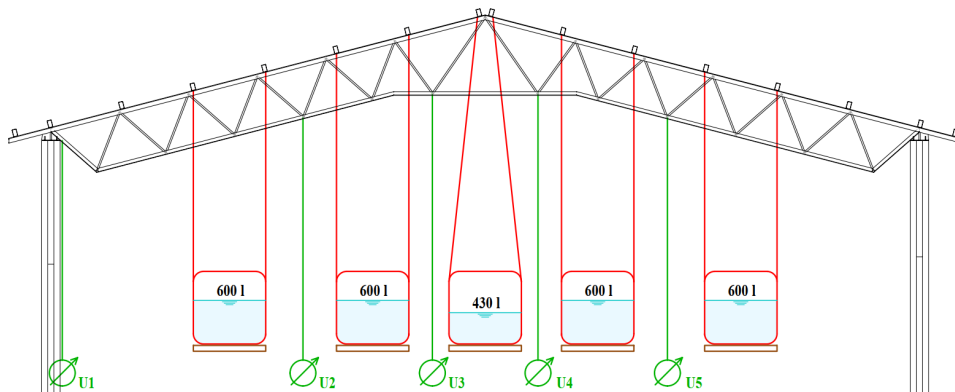
One day prior to the test, the structure was prepared. For the girder subjected to testing, five plastic tanks with corresponding pallets were suspended in accordance with the scheme shown in Figure 11. Each tank had a capacity of 1000 l, which corresponds to a load of 10 kN when the tank is filled with water.

- five mechanical dial gauges of the “Huggenberger” brand, with a measuring range of 0–5 cm and an accuracy of 0.05 mm, for monitoring deflections (vertical displacements) of the girder, installed according to the scheme shown in Figure 11;

Figure 11. Scheme of proof load for the fourth testing phase (100% load) and arrangement of mechanical dial gauges and leveling measurement points (drawing by author).

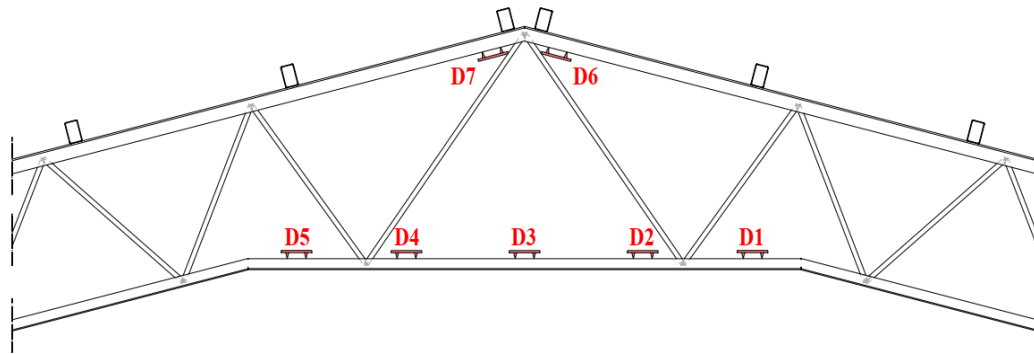
- seven deflectometers of the “Meixin” brand, with a measuring range of 0–1 mm and an accuracy of 0.001 mm, for monitoring relative elongations/shortenings of the bottom and top chords of the truss, installed according to the scheme shown in Figure 12;

Figure 12. Arrangement of deflectometers (strain gauges) (drawing by author).

It is assumed that these deviations occurred due to slight displacement of the deflectometer supports, caused by insufficiently secured adhesive, most likely as a consequence of elevated temperatures. Difficult access to the aforementioned measurement points may have further affected the accuracy and reliability of the measurements.

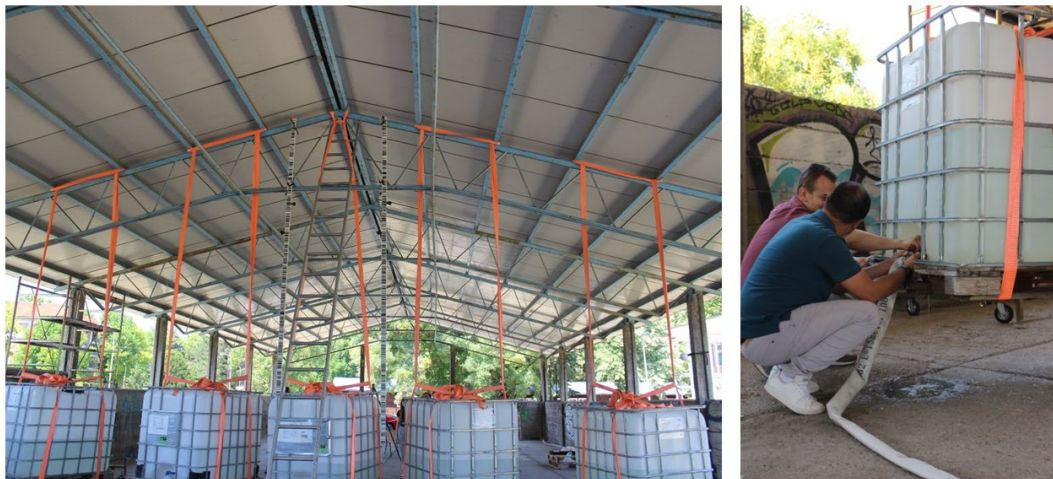
Figure 13. Proof load testing of the 'Campus garage': load application on the steel truss (left) and container unloading (right) (photography by author).

No loosening of connections between web members and chords, no slippage of chord splices, and no deformation of support zones were observed during the experiment.

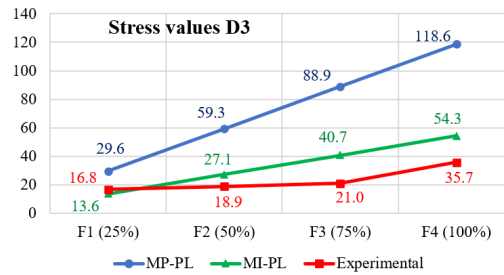
Four measurement points, D1, D2, D4, and D5, were excluded due to evident deviations in the results. The theoretically calculated and experimentally obtained stress values at the remaining

Figure 21. Theoretical and experimental stress values [MPa] at measurement point D3

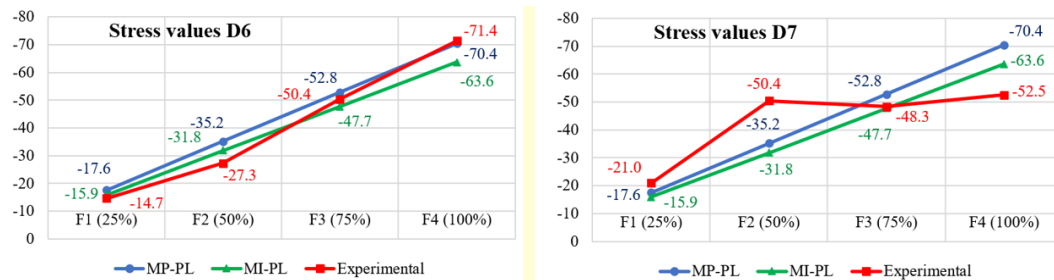
Figure 22. Theoretical and experimental stress values [MPa] at measurement point D6 (left) and D7 (right) (drawing by author).
