## GEOMATIC DATA FOR TREATMENT OF HISTORIC BRIDGES. THE CASE STUDY OF THE RIBNICA BRIDGE IN PODGORICA, MONTENEGRO

Stone bridges, all around Europe stand as enduring testaments to engineering mastery, cultural heritage, and historical continuity. They served as crucial infrastructural lifelines, connecting communities and fostering trade routes. Their enduring presence symbolizes the craftsmanship and innovation of their eras, reflecting diverse regional styles and technological advancements. Geometric documentation of a stone bridge provides critical insights into its structural integrity, aiding in preservation efforts. Accurate data obtained through geomatic techniques ensures informed conservation decisions, safeguarding the bridge's historical significance for future generations. This paper focuses on the geometric documentation of the Ribnica Bridge in Podgorica, Montenegro.

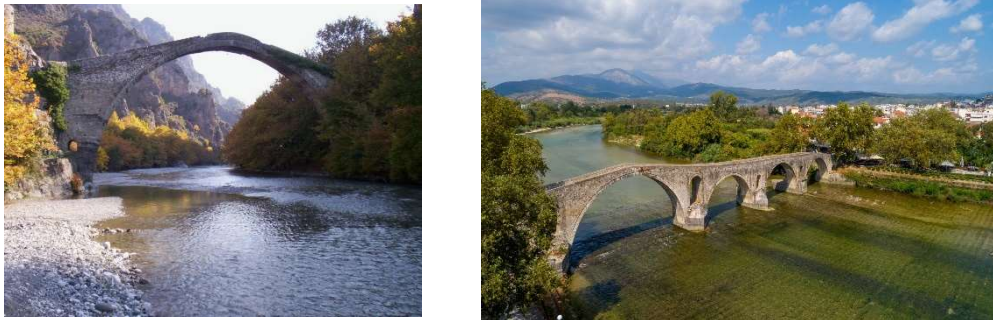
Figure 1. a) The single-arched stone bridge of Konitsa (<https://www.allovergreece.com>) b) The multi-arched stone bridge of Arta (<https://discoverarta.gr/>)

Until the 20th century, the only feasible and functional engineering work that the skilled craftsmen of that era could construct to address the transportation problem that affected not only themselves but all their fellow citizens was a stone bridge, either single-arched like the one in Konitsa (fig. 1a) or multi-arched like the one in Arta (fig. 1b).

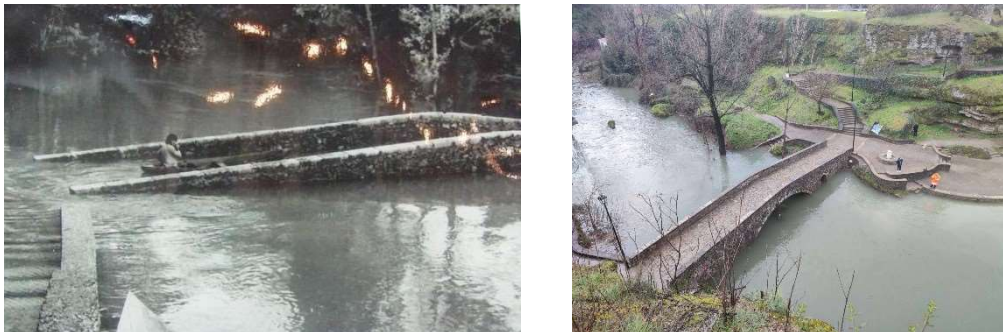
Figure 4. a) Passing Ribnica bridge in a boat b) Ribnica bridge flooded on 27/2/2023 (authors)

The bridge at Sastavci - over the river Ribnica, just before its confluence with the Morača - is the oldest bridge in Podgorica. The layout of the bridge, i.e. its vertical projection and width, indicate that it is an asymmetric bridge structure that spans the Ribnica river, and is dominated by the main opening of 10.8 m. Two smaller openings are located towards the right abutment of the bridge. Dimensionally, the opening with a width of 1.18 m, which is located next to the arch of the bridge, is more conspicuous [14]. Facilitating openings served for greater water flow, when the high waters of Ribnica and Morača (autumn-spring) would rise due to heavy rainfall, often turning the Sastavci zone into a real lake (fig. 4a, 4b). The total length of the bridge is approx. 25m.

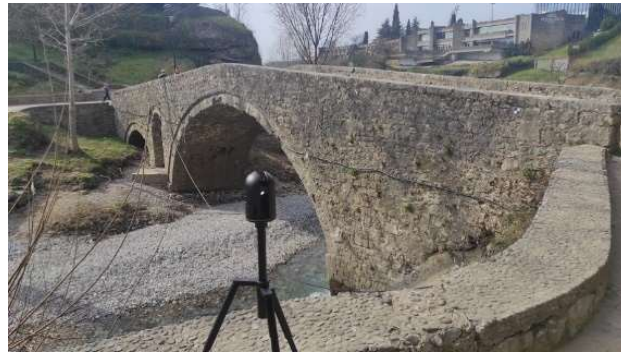
Figure 5. Ribnica bridge during scanning process (authors)

All scans were performed with a 4 mm step and the distance between the object and the scanner was always less than 20m. The percentage of the scan overlap ranged from 40% to 70%. (fig. 5)

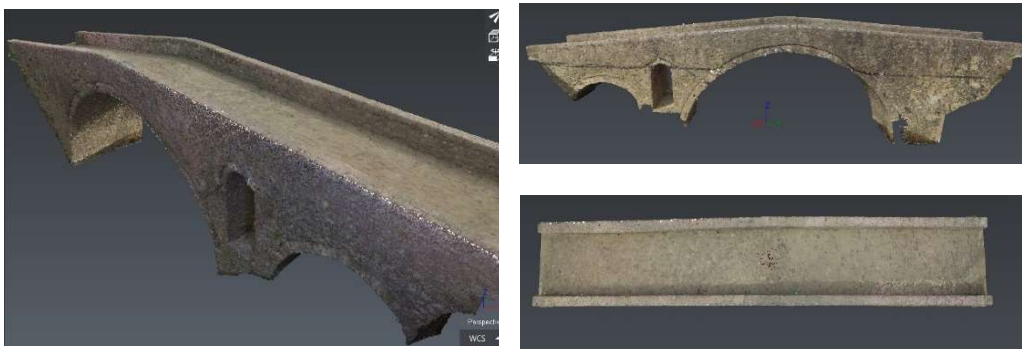
Figure 9. a) Perspective view of the model b) c). Facade and plan view

The point cloud was cleaned from noise (e.g. vegetation, obstacles etc.) and inserted in the Leica 3DR software for further processing and modeling. The cleaning of the point cloud is an essential procedure for all similar application. Keeping only the information that concerns the construction itself, reduces the final size of the file and makes the modelling more precise. The final 3D model is given RGB colors derived from the pictures than were taken from the laser scanner during the scanning process (fig. 9a, 9b, 9c)

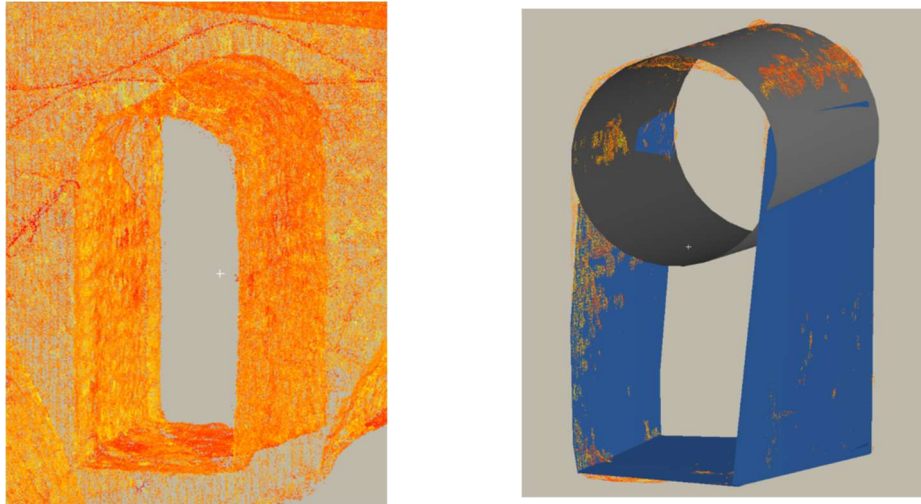
Figure 13. Snapshot of the point cloud of the first relief arch (left) and the modeled surfaces output (right).

On the merged point cloud, the region-grow algorithm was applied, and surfaces of planes and cylinders were modeled on the three arches of the bridge (Figures 13 and 14). The fit quality was with a standard deviation of 6 mm. From this modeling the initial geometric elements of the bridge were extracted.
